Annex J

Investigation Report of CEMS Exceedances

Investigation Report of Treated Effluent Leakage

Extract of the Incident Notification Form on Treated Effluent Leakage Prepared by the Contractor

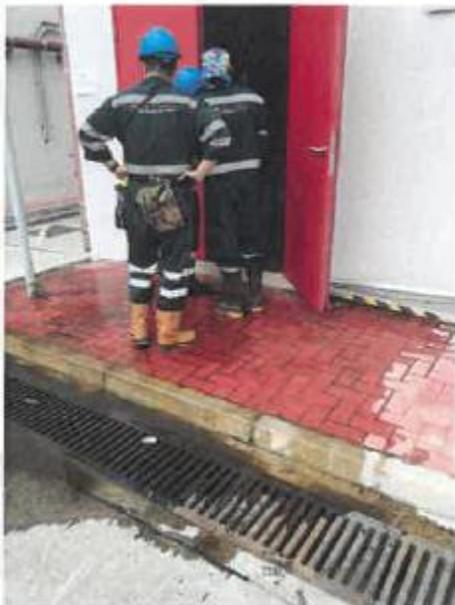
On 21st May 2019 around 15:30, brown water was found leaked out from the treated effluent pump room by maintenance team (MT) technician. Operation team (OPS) was immediately informed. MT and OPS immediate checked the pump room inside and found that the brown water was leaked from a treated effluent discharge pump (5084PS601). The team immediate stopped the pump and also isolated the valves before and after the pump.

Figure.1 Brown water was found leak from treated effluent pump room

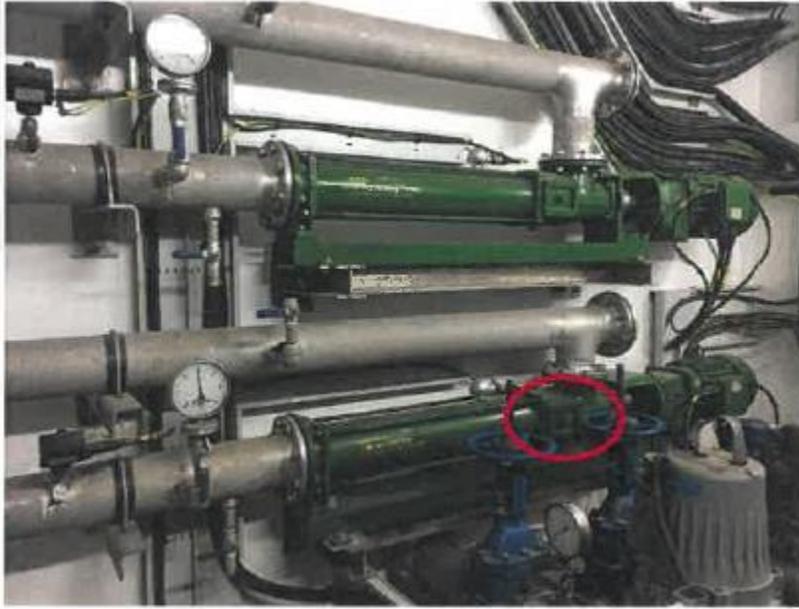
Figure.2 Leakage Location (photo was taken after the incident)

It was found that a gasket on the pump was damaged. MT was then arranged to replace the gasket and the system was resumed to normal on the same day.

1. The gasket on the pump was found damaged.
2. The treated effluent was leaked from the damaged gasket.

1. Stopped the discharged pump
2. Isolated the pump by closing the valves before and after the pump
3. Placed sandbags in the storm water channel to block the treated effluent leak to nullah
4. Cleaned up the remaining treated effluent inside the storm water system and pump back to plant's wastewater treatment system

1. Arrange routine preventive maintenance on the discharge pumps
2. Arrange routine patrol at treated effluent pump room
3. Prepare sandbags inside the pump room in order to have a faster response

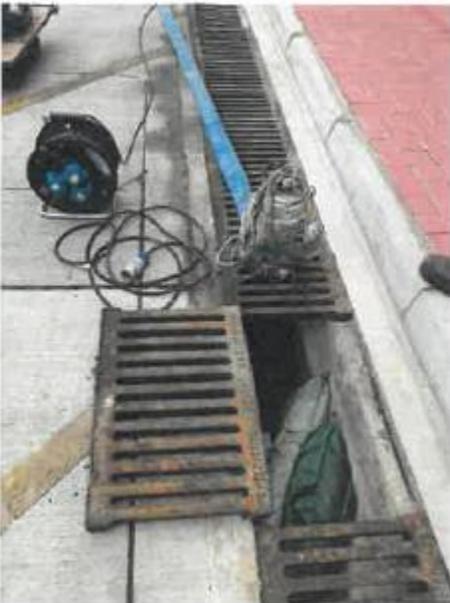
The brown water was treated effluent and was leaked to nearby storm water channel. The teams also immediate put sandbags to block the leakage. A small amount of treated effluent was found leak to the nullah.

Figure.3 Sandbags were placed at the nearby storm water channel

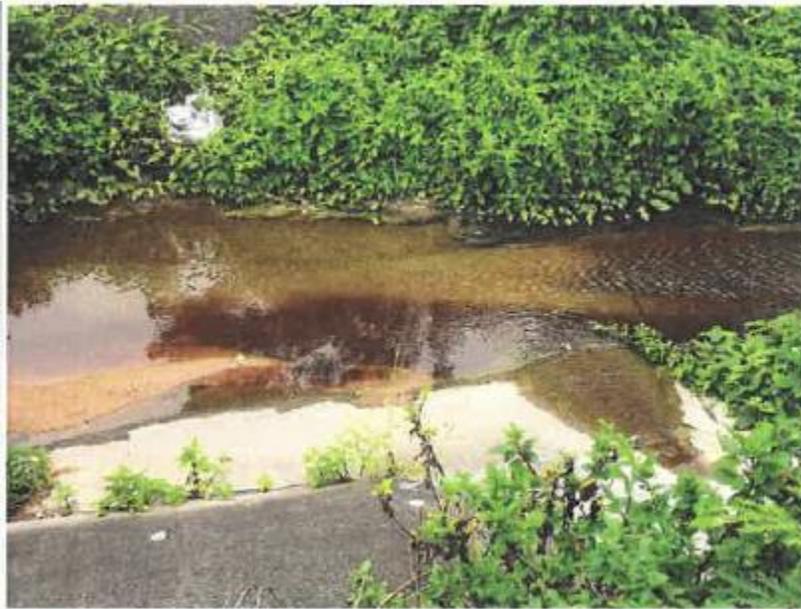
Figure.4 Brown water was found on the stormwater outlet of the plant

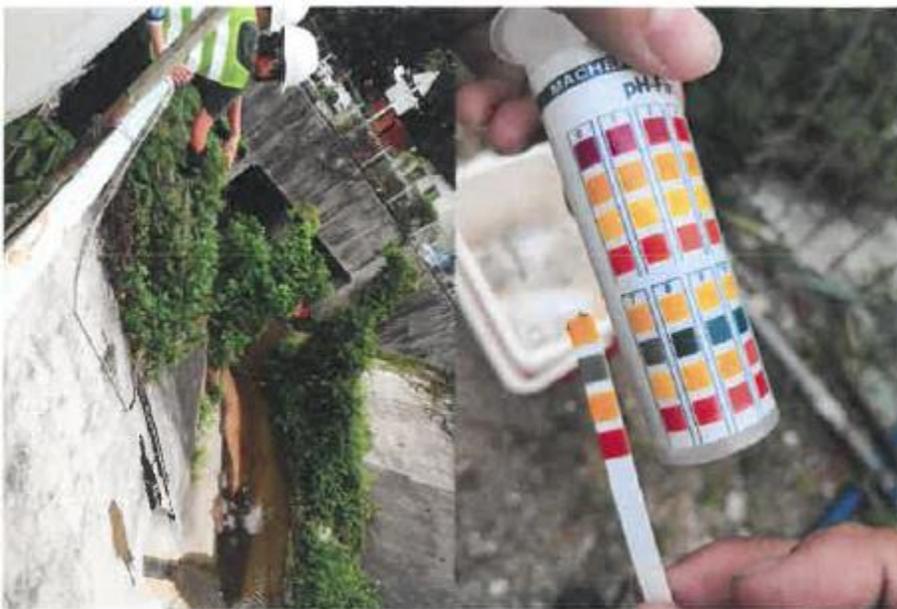
The teams then opened the petrol interceptor to clean up the residue treated effluent in the storm waste system and pump back to the plant's wastewater system. A water sample was also taken by on-site EPD representatives at the outlet and preliminary measured result was pH 7.

Figure.5 Sample was taken at the discharge outlet
