ANNEX F

INVESTIGATION REPORT

Investigation Report of Environmental Non-Compliance

EP/SP/61/10 – Organic Resources Recovery Centre Phase 1

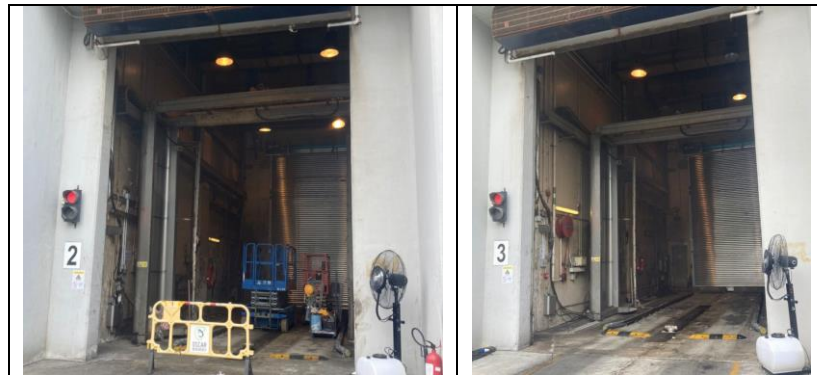
Date	19 August 2024
Time	4:10 pm
Location	Waste storage area of the main building (Detailed location and photo shown on the marked drawing Figure 3 – Site Layout attached as Appendix A)
Weather	Light rain
Non-Compliance #2	Waste storage area was suspected not operating under negative pressure as doors were broken
Relevant Requirement	EP Condition 4.2: <i>The main buildings (including waste reception and pre-treatment area, temporary storage area for shredded materials and dewatering process area, composting area and storage area) and wastewater treatment area, as shown in Figure 3, shall be operated under negative pressure to avoid escape of odour. Air in these areas shall pass through the centralized air pollution control unit for treatment before discharge.</i> General Conditions (epd.gov.hk)
Incident Description	During the August 2024 monthly site audit by the Monitoring Team (MT) and Independent Environmental Checker (IEC) together with the Contractor, both internal and external doors for keeping negative pressure of the waste storage area were found to be broken. The waste storage area was opened and suspected not operating under negative pressure. Odour was observed around the area.

6. As advised by the Contractor on 5 September 2024, the inner doors of both Bay #2 and Bay #3 had been repaired, with photos as below:

7. As advised by the Contractor on 12 September 2024, all remaining maintenance work (including all exterior door replacements) is expected to be completed within October 2024.

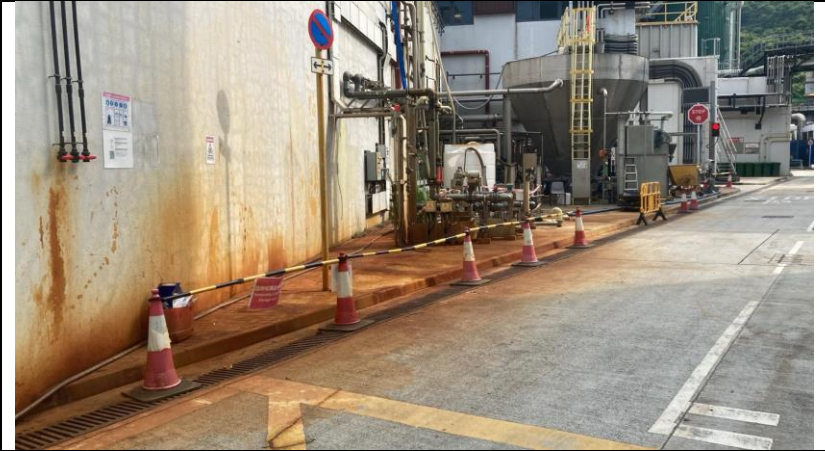
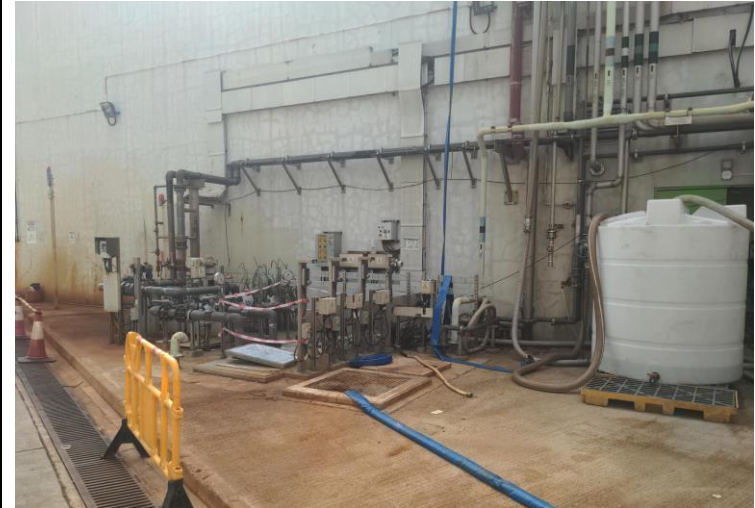
Date	19 August 2024
Time	4:20 pm
Location	Temporary chemical storage area near eastern exterior wall of Main Building of the Site (Detailed location and photo shown on the marked drawing Figure 3 - Site Layout attached as Appendix A)
Weather	Light rain
Non-Compliance #1	Suspected Chemical Spillage
Relevant Requirements	<p>Chemicals and Chemical Wastes Handling & Storage (EM&A Manual July 2019 – Revision F: Appendix A – Implementation Schedule of Mitigation Measures, EM&A Log Ref 5.22-5.25 (pg. 22-25), attached as Appendix B).</p> <p>In particular, Section 5.22 (i) First bullet: <i>“chemicals and chemical wastes should only be stored in suitable containers in purpose-built area.”</i></p> <p>Fifth bullet: <i>“Storage containers should be checked at regular intervals for their structural integrity and to ensure that the caps or fill points are tightly closed.”</i></p>
Incident Description	During the August 2024 monthly site audit by the Monitoring Team (MT) and Independent Environmental Checker (IEC) together with the Contractor, orange/ brown-coloured stains were observed on the ground and exterior wall of the Main Building. Various chemicals (i.e. FeCl ₃ and H ₂ SO ₄) in containers were observed. Some containments were found overflow to surroundings.

<p>Remedial Works and Follow-up Actions</p>	<ol style="list-style-type: none">1. The Contractor is requested to implement the above-listed actions and provide documentary evidence including photos.2. The Contractor is recommended to clean up the chemical spillage area in accordance with EM&A Manual Section 5.22 (i) (Chemical Handling and Storage) and Section 5.22(ii) (Chemical Spillage Response Plan).3. In accordance with EM&A Sections 5.23 and 5.24, Site Manager of Contractor should prepare an incident report, and Contractor should inform EPD immediately as per EM&A Section 5.25.4. The Contractor is recommended to consider moving the stored chemicals to proper indoor area, or at least to immediately provide further secondary containment, bunding protection to the stormwater drainage system, and covering from rainfall (e.g. temporary structure) in the interim.5. MT will follow-up with the Contractor on the actions and remedial works accordingly.6. As advised by the Contractor on 12 September 2024, all chemicals previously stored outdoors for wastewater treatment have been removed, with photos as below: <div data-bbox="594 930 1414 1377">
