Investigation Report

OSCAR Bioenergy Joint Venture
EP/SP/61/10 – Organic Resources Recovery Centre Phase 1

Investigation Report of Intermediate Digestate Tank Leakage

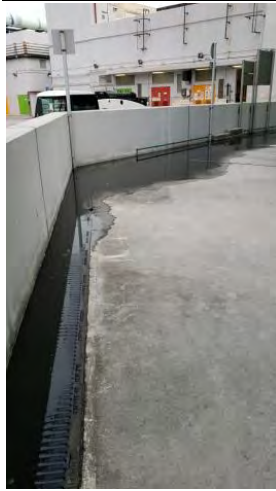
There was an incident happened in the early morning (around 08:30am). Suspension was overflowed from the IDT to the surface channel inside AD tanks farm (Figure 1). OSCAR was carrying out cleaning work inside the tank farm. OSCAR had checked the discharge outlet at around 9:30 and did not find any leakage at that moment. OSCAR also kept monitor the outlet by using CCTV. The 3-way gate valve was believed fully closed and the team did not aware suspension would pass through the 3-way gate valve.

Photo.1 Overflow of Suspension from IDT

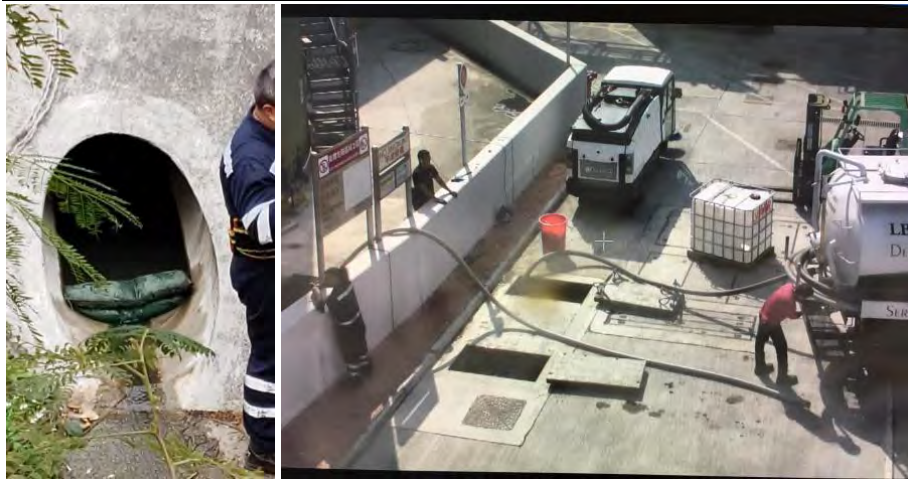
Figure.2&3 Sandbags was put at the discharge outlet and Vacuum tanker truck was arranged to cleanup

The team immediate put sandbags at the stormwater discharge outlet to block the leakage. OSCAR also arranged a vacuum tanker truck immediately to clean up the suspension at the nullah (Figure 2&3). Cleaning work for the spillage inside the tank farm, nearby surface channel and around the IDT was also completed at around 4:00 pm (Figure 4).

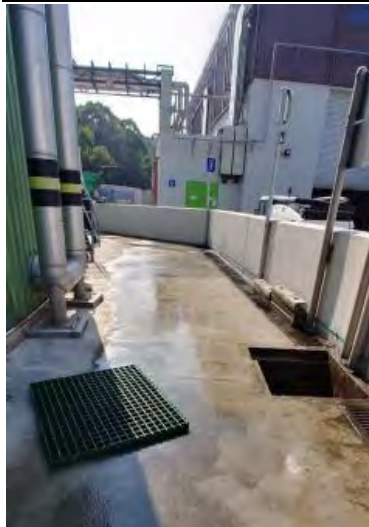
Figure.4 Completed cleanup of tank farm and nearby surface channels

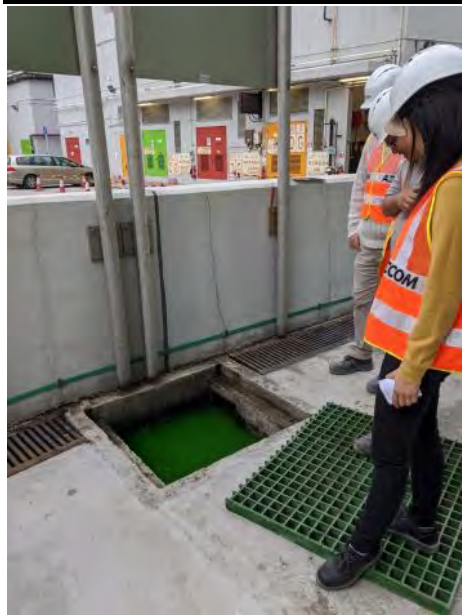
Figure.5 Dye test carried out on 30 December to ensure the gate valve is fully closed

7. The 3-way valve was closed at the time of the outbreak. Unfortunately the 3-way valve was not able to tight seal and some of the suspension passed through the valve and leaked to the nullah slowly.

1. To check and fully close the 3-way gate valve to prevent possible leakage to nullah.
2. To carry out dye test to check the 3-way valve is fully closed.
3. To keep close monitoring the IDT level for each process (centrifuge and flushing).
4. To carry out programme enhancement to avoid injection of flushing water to IDT that may due to any interruption of programme sequence/logic.
