Investigation Report

OSCAR Bioenergy Joint Venture EP/SP/61/10 - Organic Resources Recovery Centre Phase 1

Investigation Report of Intermediate Digestate Tank Leakage

Investigation Report of Treated Effluent Leakage

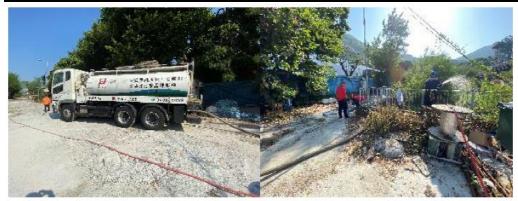
The team immediate arranged to clean up the spillage inside the tank farm, nearby surface channel and around the IDT. A vacuum tanker truck was also immediate arranged to clean up the suspension at the nullah (*Figure 1*). All the cleanup work was completed at around 11:00am. (*Figure 2* and 3)

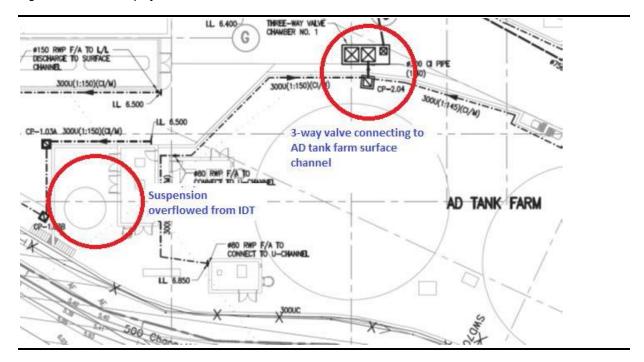
Figure.4 Location map of the incident

On 5/11/2019 morning at around 7:50am, black water was found discharging to the nullah from the storm water discharge channel. The team immediate carried out investigation to identify if there had any leakage from the plant. It was found that suspension was overflowed from the overflow tank of IDT to the surface channel inside AD tanks farm. Operation Team immediate contacted the Central Control Room to stop all feedings to the IDT. The suspension was stopped overflowed from the IDT overflow tank immediately.

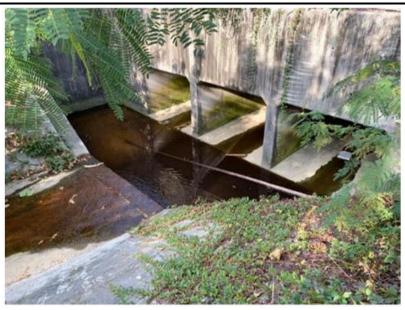
At around 8:00am, it was reported that some brown colour water was found at the pit of nullah (*Figure 1*). However, water from the plant's stormwater discharge outlet was clean (*Figure 2*). The team immediately checked the plant and did not find any leakage at that moment. The team therefore double checked the 3-way gate valve and found that the 3-way gate valve was not at "fully closed" position. The brown colour water was suspected leaked during the early morning incident through the 3-way gate valve. It is considered only small amount of TE was leaked to nullah during the early morning incident. This is because most of the overflowed TE was diverted to the drain pit inside the TE pump room and only some of TE end up at the nearby stormwater channel. Moreover, the 3-way gate valve is at an "almost close" position.

Figure.1 Slightly brown colour water at the pit of nullah

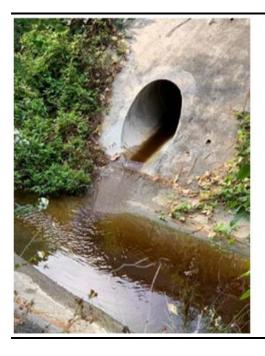
Figure.2 Clean water at the stormwater discharge outlet

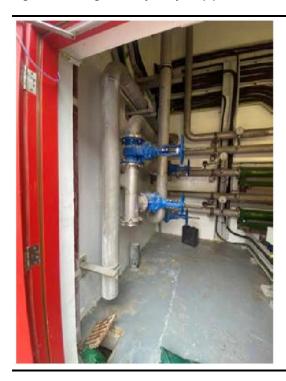
- 1. The cause of high level TE was resulted from previous plant blackout test and caused SBR system power down. The system reset the decant process status and decant again. Twice decant caused high level TE.
- 2. The overflow pipeline was not directly pointed to the drain pit inside the TE pump room (*Figure 3*)

- 3. Overflowed TE was discharged on the floor inside the TE pump room rather than to the drain pit
- 4. Small amount of overflowed TE was leaked outside the TE pump room through the gap of the pre-installed sandbags
- 5. A small amount of TE end up at nearby stormwater channel and is suspected leak to the nullah through the "not fully closed" 3-way gate valve.

Figure.3 Misalignment of overflow pipeline to the drain pit inside the TE pump room

- 1. To install PVC Pipe to divert the overflow pipeline to the drain pit inside TE pump room
- 2. To place and erect a better sandbags wall inside the TE pump room
- 3. To fully close the 3-way gate valve
- 4. To erect a 200mm height bund wall to prevent similar incidents.
- 5. To review the redesign of the overflow pipeline
