Investigation Report

Investigation Report of CEMS Exceedances

OSCAR Bioenergy Joint Venture
EP/SP/61/10 – Organic Resources Recovery Centre Phase 1

Investigation Report of Intermediate Digestate Tank Leakage

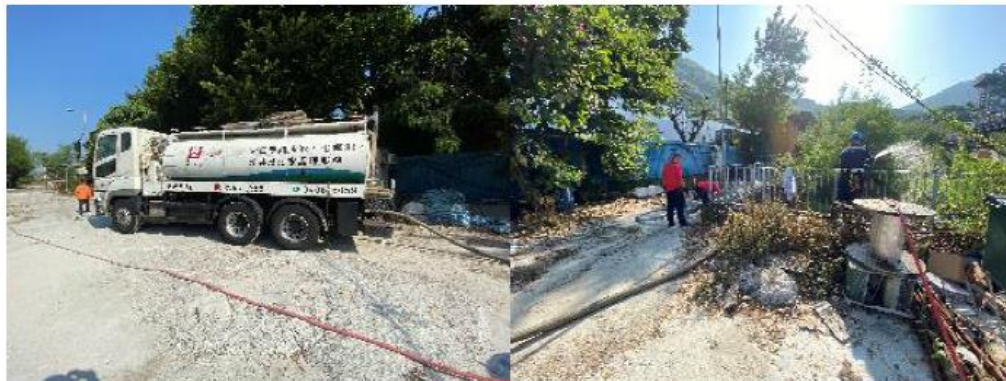
The team immediate arranged to clean up the spillage inside the tank farm, nearby surface channel and around the IDT. A vacuum tanker truck was also immediate arranged to clean up the suspension at the nullah (Figure 1). All the cleanup work was completed at around 11:00am. (Figure 2 and 3)

Figure.1 Vacuum tanker was arranged to cleanup the nullah

1. Stopped all the feedings to the IDT
2. Arranged to clean up the suspension leaked to the nullah by a vacuum tanker truck
3. Arranged to clean up the suspension at the surface channel near the IDT

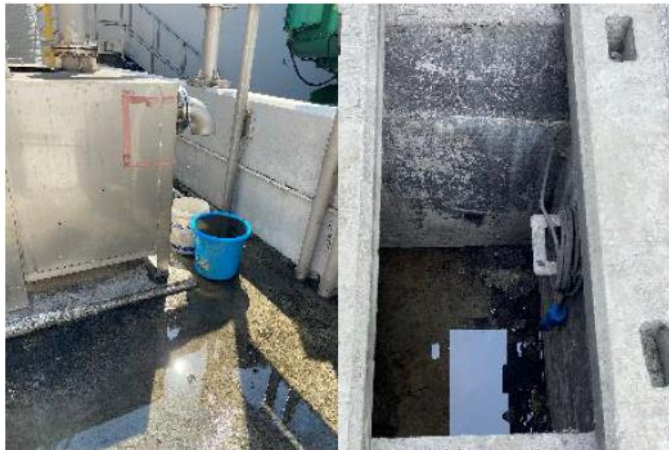
Figure.2 Completed cleanup of tank farm and nearby surface channels

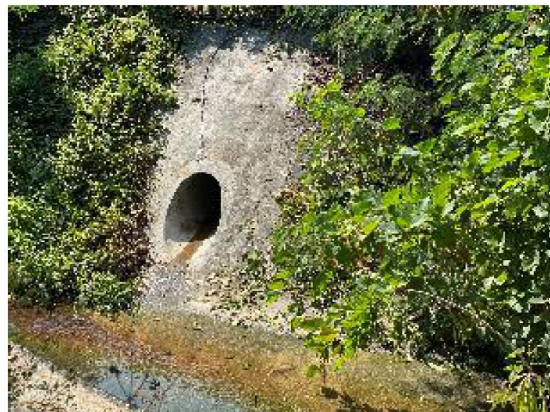
Figure.3 Complete cleanup of nullah

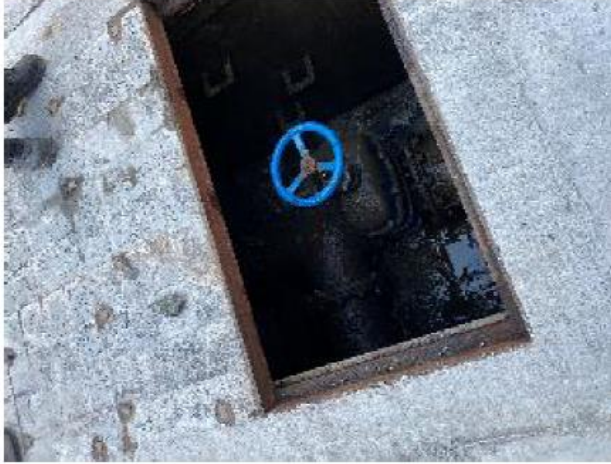
1. After the dewatering process, the team started flushing the system. However, the team did not aware that process water was injecting to the IDT.
2. Process water will stop injecting to IDT by a default period. However, the process water injection was not stopped. *(To be further investigated by system programmer)*
3. The team did not aware the IDT tank was reaching high level and overflowed to the overflow tank
4. Process water with residual suspension overflowed from IDT to the overflow tank.
5. Process water with residual suspension overflowed to the surface channel at AD tank farm and discharged to the nullah.
6. The 3-way valve (*Figure 4*) is believed opened 1-2 months ago because of a heavy rainstorm. The 3-way valve however did not close after the heavy rainstorm.

*FigureError! No text of specified style in document..5
gate valve is closed*

Preventive action: AD tank from stormwater 3-way

1. To close the 3-way gate valve to prevent possible leakage to nullah (Figure 5)
2. To keep close monitoring the IDT level for each flushing process (duty suspensor will monitor each flushing process every time with the assistant of CCTV)
3. To increase the routine patrol frequency by one time per shift to 2 times per shift
4. To further investigate by system programmer to check if there have any programming bugs

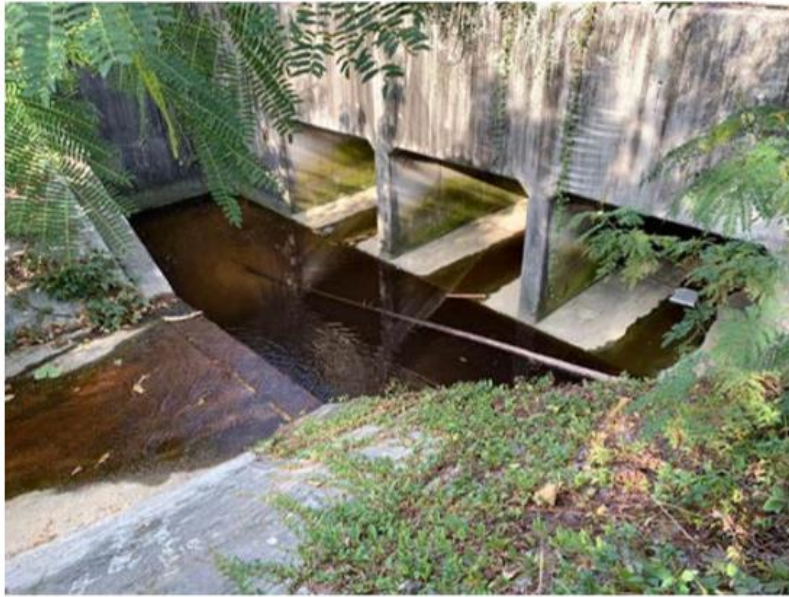
At around 8:00am, it was reported that some brown colour water was found at the pit of nullah (Figure 1). However, water from the plant's stormwater discharge outlet was clean (Figure 2). The team immediately checked the plant and did not find any leakage at that moment. The team therefore double checked the 3-way gate valve and found that the 3-way gate valve was not at "fully closed" position. The brown colour water was suspected leaked during the early morning incident through the 3-way gate valve. It is considered only small amount of TE was leaked to nullah during the early morning incident. This is because most of the overflowed TE was diverted to the drain pit inside the TE pump room and only some of TE end up at the nearby stormwater channel. Moreover, the 3-way gate valve is at an "almost close" position.

Figure.1 Slightly brown colour water at the pit of nullah

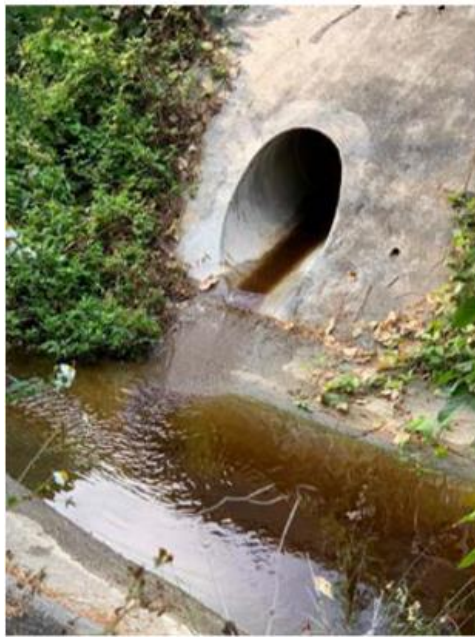
Figure.2 Clean water at the stormwater discharge outlet

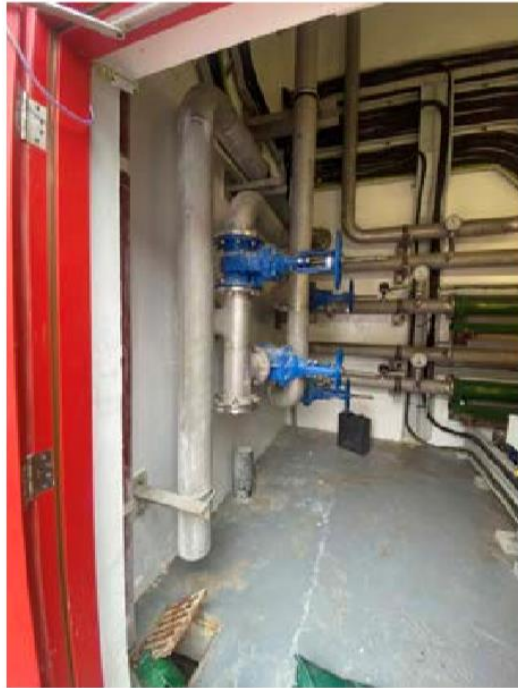
1. The cause of high level TE was resulted from previous plant blackout test and caused SBR system power down. The system reset the decant process status and decant again. Twice decant caused high level TE.
2. The overflow pipeline was not directly pointed to the drain pit inside the TE pump room (Figure 3)

3. Overflowed TE was discharged on the floor inside the TE pump room rather than to the drain pit
4. Small amount of overflowed TE was leaked outside the TE pump room through the gap of the pre-installed sandbags
5. A small amount of TE end up at nearby stormwater channel and is suspected leak to the nullah through the “not fully closed” 3-way gate valve.

Figure.3 Misalignment of overflow pipeline to the drain pit inside the TE pump room

1. To install PVC Pipe to divert the overflow pipeline to the drain pit inside TE pump room
2. To place and erect a better sandbags wall inside the TE pump room
3. To fully close the 3-way gate valve
4. To erect a 200mm height bund wall to prevent similar incidents.
5. To review the redesign of the overflow pipeline
