Investigation Report

OSCAR Bioenergy Joint Venture
EP/SP/61/10 – Organic Resources Recovery Centre Phase 1

Investigation Report of Intermediate Digestate Tank Leakage

Extract of the Incident Notification Form on Suspension Overflow at IDT Prepared by the Contractor

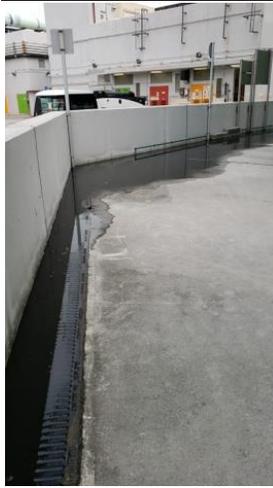
There was an incident happened in the early morning (around 08:30am). Suspension was overflowed from the IDT to the surface channel inside AD tanks farm (Figure 1). OSCAR was carrying out cleaning work inside the tank farm. OSCAR had checked the discharge outlet at around 9:30 and did not find any leakage at that moment. OSCAR also kept monitor the outlet by using CCTV. The 3-way gate valve was believed fully closed and the team did not aware suspension would pass through the 3-way gate valve.

Photo.1 Overflow of Suspension from IDT

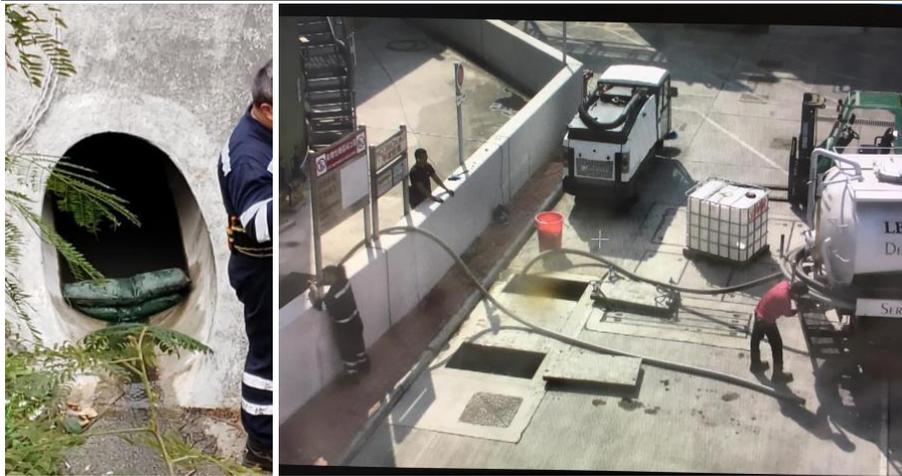
Figure.2&3 Sandbags was put at the discharge outlet and Vacuum tanker truck was arranged to cleanup

The team immediate put sandbags at the stormwater discharge outlet to block the leakage. OSCAR also arranged a vacuum tanker truck immediately to clean up the suspension at the nullah (Figure 2&3). Cleaning work for the spillage inside the tank farm, nearby surface channel and around the IDT was also completed at around 4:00 pm (Figure 4).

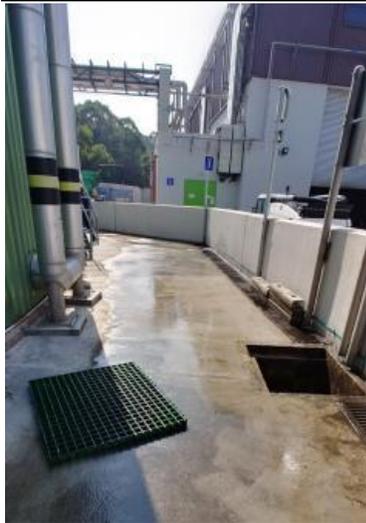
Figure.4 Completed cleanup of tank farm and nearby surface channels

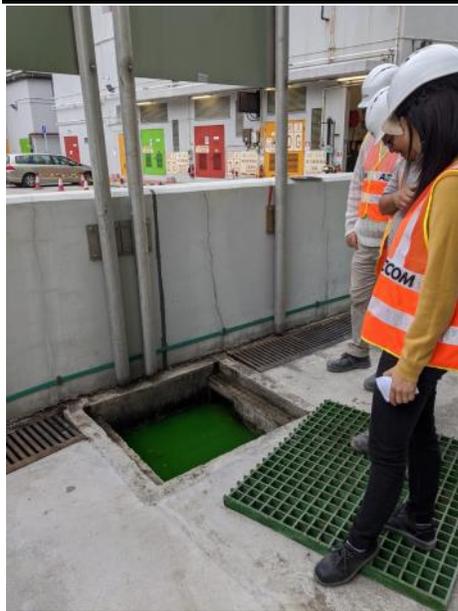
Figure.5 Dye test carried out on 30 December to ensure the gate valve is fully closed

7. The 3-way valve was closed at the time of the outbreak. Unfortunately the 3-way valve was not able to tight seal and some of the suspension passed through the valve and leaked to the nullah slowly.

1. To check and fully close the 3-way gate valve to prevent possible leakage to nullah.
2. To carry out dye test to check the 3-way valve is fully closed.
3. To keep close monitoring the IDT level for each process (centrifuge and flushing).
4. To carry out programme enhancement to avoid injection of flushing water to IDT that may due to any interruption of programme sequence/logic.
