Annex K

Investigation Report –
Odour Sampling
Exceedances

OSCAR Bioenergy Joint Venture
EP/SP/61/10 – Organic Resources Recovery Centre Phase 1

Investigation Report of Treated Effluent Leakage

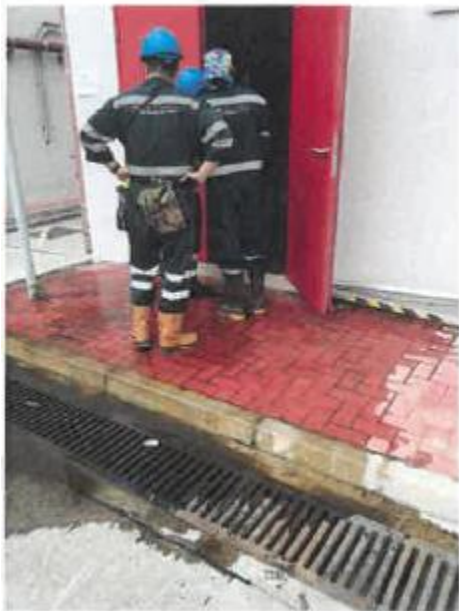
On 21st May 2019 around 15:30, brown water was found leaked out from the treated effluent pump room by maintenance team (MT) technician. Operation team (OPS) was immediately informed. MT and OPS immediate checked the pump room inside and found that the brown water was leaked from a treated effluent discharge pump (5084PS601). The team immediate stopped the pump and also isolated the valves before and after the pump.

Figure.1 Brown water was found leak from treated effluent pump room

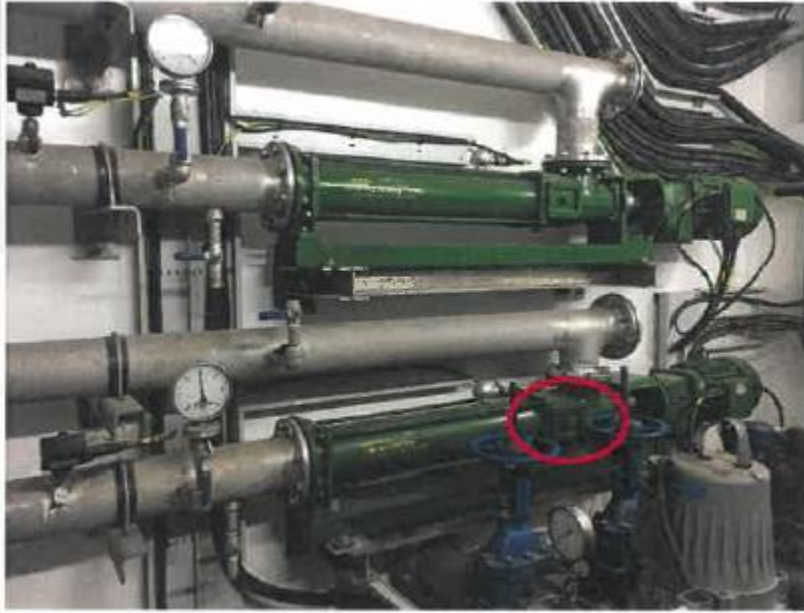
Figure.2 Leakage Location (photo was taken after the incident)

It was found that a gasket on the pump was damaged. MT was then arranged to replace the gasket and the system was resumed to normal on the same day.

1. The gasket on the pump was found damaged.
2. The treated effluent was leaked from the damaged gasket.

1. Arrange routine preventive maintenance on the discharge pumps
2. Arrange routine patrol at treated effluent pump room
3. Prepare sandbags inside the pump room in order to have a faster response

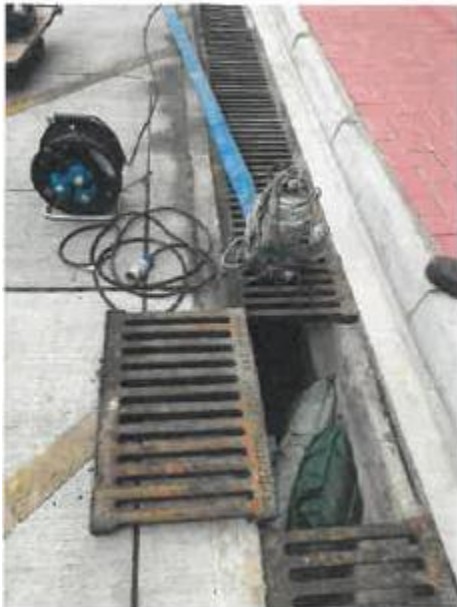
The brown water was treated effluent and was leaked to nearby storm water channel. The teams also immediate put sandbags to block the leakage. A small amount of treated effluent was found leak to the nullah.

Figure.3 Sandbags were placed at the nearby storm water channel

1. Stopped the discharged pump
2. Isolated the pump by closing the valves before and after the pump
3. Placed sandbags in the storm water channel to block the treated effluent leak to nullah
4. Cleaned up the remaining treated effluent inside the storm water system and pump back to plant's wastewater treatment system

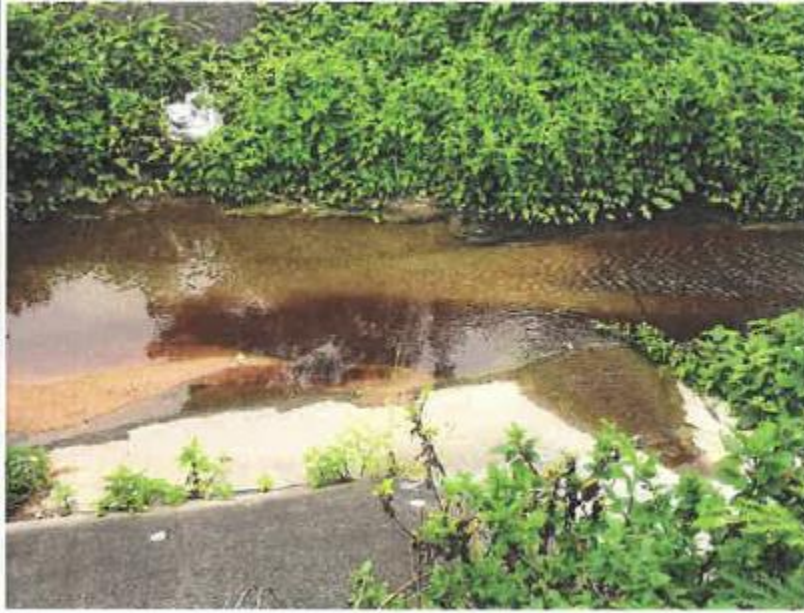
Figure.4 Brown water was found on the stormwater outlet of the plant

There was no brown water found at the discharge outlet and the nullah after the cleanup work completed on the same day.

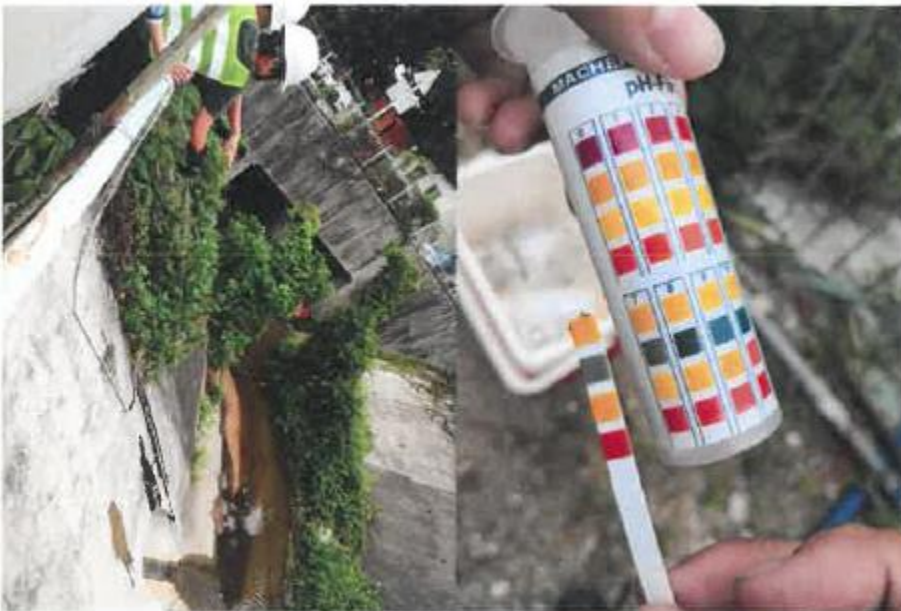
The teams then opened the petrol interceptor to clean up the residue treated effluent in the storm waste system and pump back to the plant's wastewater system. A water sample was also taken by on-site EPD representatives at the outlet and preliminary measured result was pH 7.

Figure.5 Sample was taken at the discharge outlet
