Annex F

## Investigation Report

**Investigation Report of CEMS Exceedances**

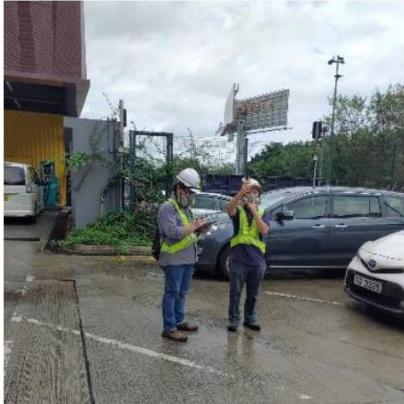
Date	6 July 2022
Time	10:42 am
Monitoring Location	Location 7 (at the car park outside the Visitor Centre)

Parameter	Odour Intensity
Exceedance Description	<ol style="list-style-type: none"> <li>1. According to the EM&amp;A Manual, exceedance is considered if Odour Intensity recorded at the odour patrol is Level 2 or above. During the odour patrol on 6 July 2022 morning, the odour patrol panellists identified the scent of garbage with Odour Intensity of 2 at location 7 (refer to Annex G for location detail). An Odour Intensity lower than 2 was later recorded at the same monitoring location in the afternoon of the same day.</li> <li>2. An investigation was carried out by the Contractor and the source of the odour was a mixture of the scents of garbage and the de-odorising agent used for the Suspension Buffer Tank (SBT) cleaning undertaken during the odour patrol <sup>(1)</sup>.</li> </ol>
Action Taken / Action to be Taken	Another round of odour patrol was carried out on 19 July 2022, the Odour Intensity recorded from this odour patrol was under 2 (refer to Annex G for the result of both rounds of odour patrol).

Remedial Works and Follow-up Actions	The Contractor is currently exploring alternative de-odorising agent(s) to minimise the odour impact.
