## Investigation Report

## Investigation Report for December 2021

**Investigation Report of CEMS Exceedances**

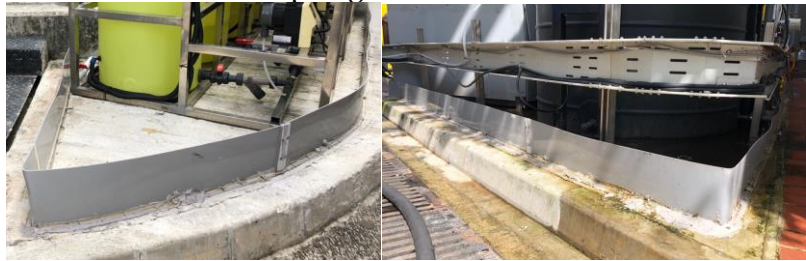
Date	23, 28 and 29 December 2021
Incident Description	<p>Foam overflow from tanks to surface channel from the Anammox Pilot Plant was reported on 23 and 28 December 2021. The Contractor found no discharge to the nearby channel on 23 and 28 December 2021.</p> <p>Wastewater leakage from a loosen flexible pipe of the Anammox Pilot Plant was reported on 29 December 2021.</p>
Action Taken / Action to be Taken	The leakage on 29 December 2021 was intercepted and wastewater was diverted to the wastewater treatment system.
Remedial Works and Follow-up Actions	<p>A containment bund has been constructed around the pilot plant to contain any future spillages. Communication channel between site and plot operator has been established for immediate control actions in the case of spillage.</p>
