# Contract No. EP/SP/61/10 Organic Resources Recovery Centre (Phase 1)

One Hundred and Eleventh Monthly  
EM&A Report (August 2024)

PREPARED FOR  
OSCAR Bioenergy Joint Venture

Monthly EM&A Report  
(1 August 2024 – 31 August 2024)

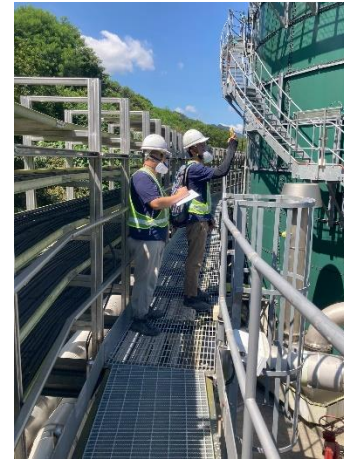
**Location: 3**

During the reporting period, one (1) Action Level exceedance (detection of Odour Intensity Level 2) was recorded during the independent odour patrol at Location 3 (Biogas Tank Valve Holder) on 9 August 2024.

Action Taken / Action to be Taken	Ad-hoc odour patrol was arranged by the Contractor on 15 August 2024 and was conducted by the independent odour patrol team of ALS to confirm findings. The ad-hoc odour patrol identified a further three (3) Level 2 exceedances and one (1) Level 3 exceedance, constituting an exceedance of the Limit Level under the EM&A Manual.
Remedial Works and Follow-up Actions	As remedial actions, the Contractor installed 2 pieces of canvas to replace the broken shutter doors of Bay #2 and Bay #3 and also continued with maintenance of the broken shutter doors. Installation of the inner shutter doors of Bay #2 and Bay #3 commenced on 19 August 2024 and completed on 5 September 2024. The repaired shutter doors are expected to be fully completed in October 2024. Finally, the Contractor also added additional fans with artificial flavouring to help mitigate the odour. The Contractor will continue to monitor the odour intensity and arrange independent odour patrol in the next month.
