Contract No. EP/SP/61/10 Organic Resources Recovery Centre (Phase 1)

One Hundred and Twelfth Monthly
EM&A Report (September 2024)

**Organic Resources Recovery Centre,
Phase I**

Monthly EM&A Report
(1 September 2024 – 30 September 2024)

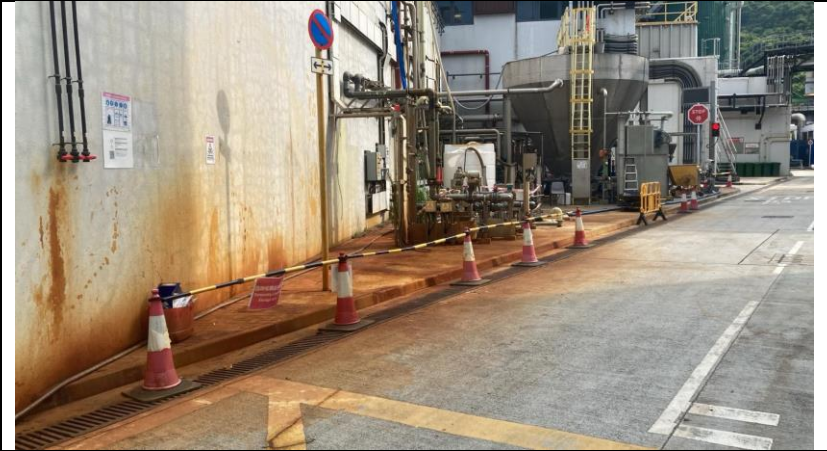
Information provided by the Contractor	<ol style="list-style-type: none"> 1. Various chemicals (i.e. FeCl₃ and H₂SO₄) in containers were observed, and the Contractor informed MT and IEC that these chemicals were temporarily stored in the area, with pumping system feeding into the wastewater system, as there was insufficient space to store the chemicals indoors. 2. The following details are provided by the Contractor: <ol style="list-style-type: none"> a) The surface channel will pass through the petrol interceptor. If any chemical/ oil flows to the drain, the chemical/ oil can be collected by the petrol interceptor. b) Although the petrol interceptor is not designed for this specific purpose, it can be isolated and serves as a buffer tank in case of any chemical spillage. c) The Intermediate Bulk Containers (IBCs) (1000 L capacity) are placed on drip trays, which have an approximate storage capacity of 265 L, more than 20% of the total IBC volume. d) The Contractor observed that the drip trays contained rainwater and mixed with a small amount of unknown material. The Contractor collected those from the tray and

<p>handled as chemical waste accordingly. The Contractor confirmed that no chemical spill was observed outside the drip trays on the day of inspection in August.</p> <p>e) The Operation Team inspects the chemical storage area once per week.</p>
<p>Review reasons and implications of non-compliance</p>	<p>Chemicals were stored temporarily outside the purpose-built area due to insufficient space.</p> <p>The chemicals were all observed marked with chemical labels and secondary containment, however it was noted that due to the heavy rain, the secondary containments were overflowing onto the ground surface and the front drain. The orange/ brown-coloured staining was suspected to be caused by the iron-containing chemicals (FeCl₃) and/ or low pH due to the acid (H₂SO₄).</p> <p>Caps of the chemical tanks were not closed. Overflow occurred during heavy rain.</p>
<p>Action Taken / Action to be Taken</p>	<ol style="list-style-type: none"> 1. The Contractor will increase inspection frequency, especially when there is heavy rain and when there is rainstorm warning from HKO. 2. The Contractor will use vacuum truck to collect the contaminated water inside the petrol interceptor if required. 3. The Contractor will collect any chemicals and liquids from the from the drip trays and handle them as chemical waste.

<p>Remedial Works and Follow-up Actions</p>	<ol style="list-style-type: none">1. The Contractor is requested to implement the above-listed actions and provide documentary evidence including photos.2. The Contractor is recommended to clean up the chemical spillage area in accordance with EM&A Manual Section 5.22 (i) (Chemical Handling and Storage) and Section 5.22(ii) (Chemical Spillage Response Plan).3. In accordance with EM&A Sections 5.23 and 5.24, Site Manager of Contractor should prepare an incident report, and Contractor should inform EPD immediately as per EM&A Section 5.25.4. The Contractor is recommended to consider moving the stored chemicals to proper indoor area, or at least to immediately provide further secondary containment, bunding protection to the stormwater drainage system, and covering from rainfall (e.g. temporary structure) in the interim.5. MT will follow-up with the Contractor on the actions and remedial works accordingly.6. As advised by the Contractor on 12 September 2024, all chemicals previously stored outdoors for wastewater treatment have been removed, with photos as below: <div data-bbox="594 930 1416 1377">
