Contract No. EP/SP/61/10
Organic Resources Recovery
Centre (Phase 1):
Fifty-fourth Monthly EM&A Report

1 November 2019 – 30 November 2019

**Organic Resources Recovery Centre,
Phase I**

Monthly EM&A Report
(1 November 2019 – 30 November 2019)

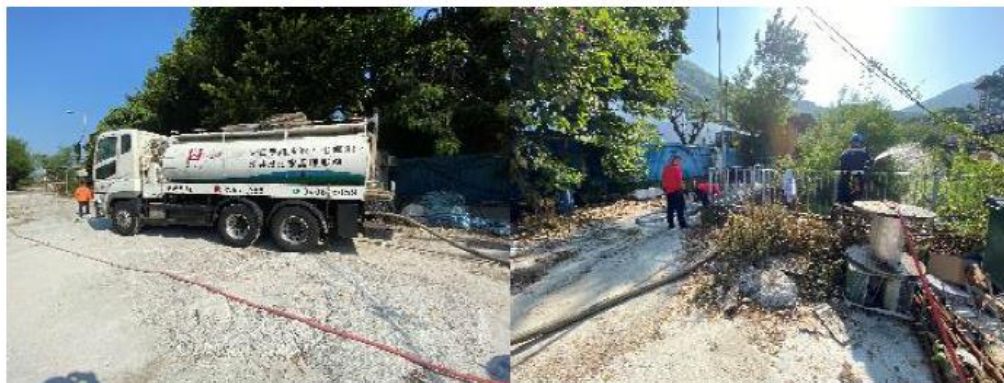
Figure.1 Vacuum tanker was arranged to cleanup the nullah

On 5/11/2019 morning at around 7:50am, black water was found discharging to the nullah from the storm water discharge channel. The team immediate carried out investigation to identify if there had any leakage from the plant. It was found that suspension was overflowed from the overflow tank of IDT to the surface channel inside AD tanks farm. Operation Team immediate contacted the Central Control Room to stop all feedings to the IDT. The suspension was stopped overflowed from the IDT overflow tank immediately.

The team immediate arranged to clean up the spillage inside the tank farm, nearby surface channel and around the IDT. A vacuum tanker truck was also immediate arranged to clean up the suspension at the nullah (*Figure 1*). All the cleanup work was completed at around 11:00am. (*Figure 2 and 3*)

1. Stopped all the feedings to the IDT
2. Arranged to clean up the suspension leaked to the nullah by a vacuum tanker truck
3. Arranged to clean up the suspension at the surface channel near the IDT
