Contract No. EP/SP/61/10  
Organic Resources Recovery  
Centre (Phase 1):  
*Eighteenth Quarterly EM&A  
Summary Report*

1 September 2019 – 31 November 2019

**Organic Resources Recovery Centre,  
Phase I**

18<sup>th</sup> Quarterly EM&A Summary Report  
(1 September 2019 – 30 November 2019)

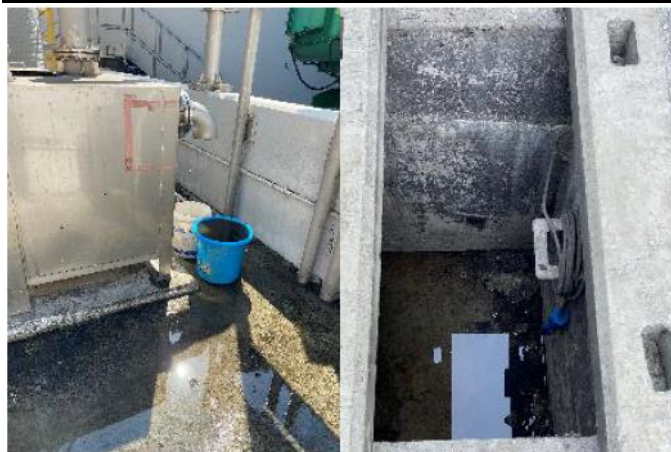
*Figure.2 Completed cleanup of tank farm and nearby surface channels*

1. Stopped all the feedings to the IDT
2. Arranged to clean up the suspension leaked to the nullah by a vacuum tanker truck
3. Arranged to clean up the suspension at the surface channel near the IDT

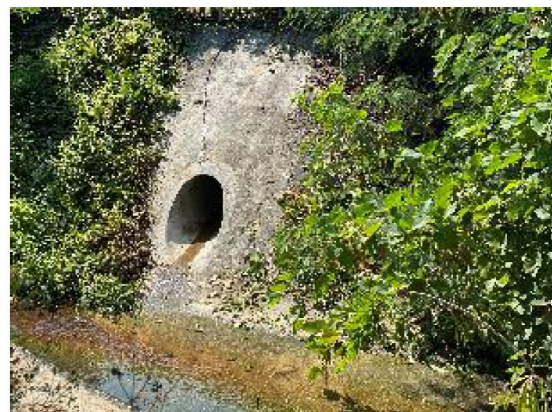
*Figure.3 Complete cleanup of nullah*

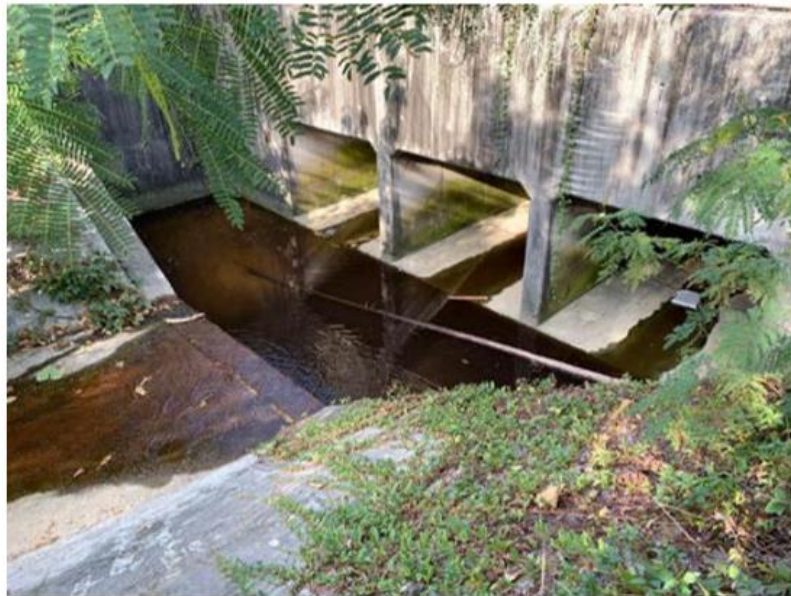
At around 8:00am, it was reported that some brown colour water was found at the pit of nullah (*Figure 1*). However, water from the plant's stormwater discharge outlet was clean (*Figure 2*). The team immediately checked the plant and did not find any leakage at that moment. The team therefore double checked the 3-way gate valve and found that the 3-way gate valve was not at "fully closed" position. The brown colour water was suspected leaked during the early morning incident through the 3-way gate valve. It is considered only small amount of TE was leaked to nullah during the early morning incident. This is because most of the overflowed TE was diverted to the drain pit inside the TE pump room and only some of TE end up at the nearby stormwater channel. Moreover, the 3-way gate valve is at an "almost close" position.

*Figure.1 Slightly brown colour water at the pit of nullah*

1. Stopped the decanting process from SBR to TE tank
2. Placed sandbags to control and divert the wastewater to a drain pit inside TE pump room.
3. Used road sweeper to cleanup nearby surface channel and the road outside TE pump room.

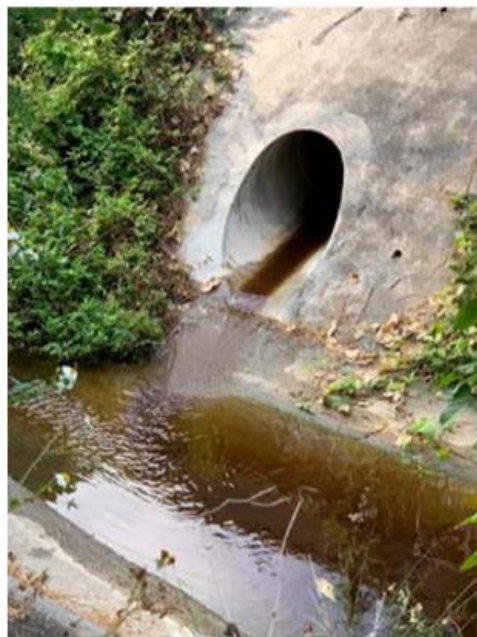
*Figure.2 Clean water at the stormwater discharge outlet*

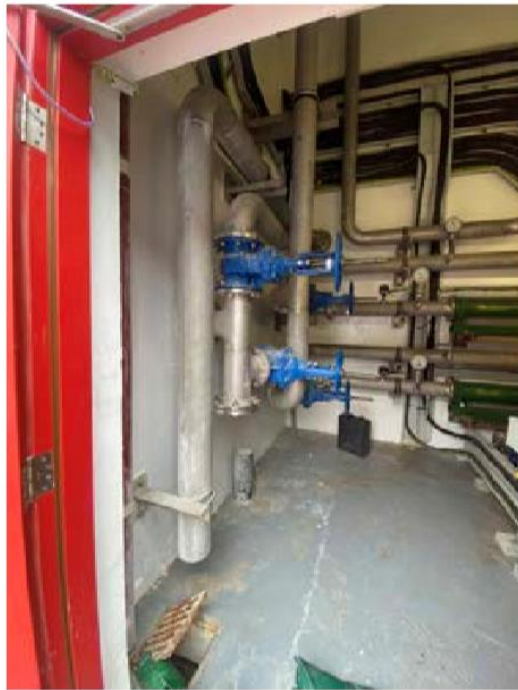
1. The cause of high level TE was resulted from previous plant blackout test and caused SBR system power down. The system reset the decant process status and decant again. Twice decant caused high level TE.
2. The overflow pipeline was not directly pointed to the drain pit inside the TE pump room (Figure 3)

3. Overflowed TE was discharged on the floor inside the TE pump room rather than to the drain pit
4. Small amount of overflowed TE was leaked outside the TE pump room through the gap of the pre-installed sandbags
5. A small amount of TE end up at nearby stormwater channel and is suspected leak to the nullah through the “not fully closed” 3-way gate valve.

*Figure.3 Misalignment of overflow pipeline to the drain pit inside the TE pump room*
