Investigation Report

Investigation Report of Odour Sampling Exceedance

Investigation Report of Odour Sampling Exceedances

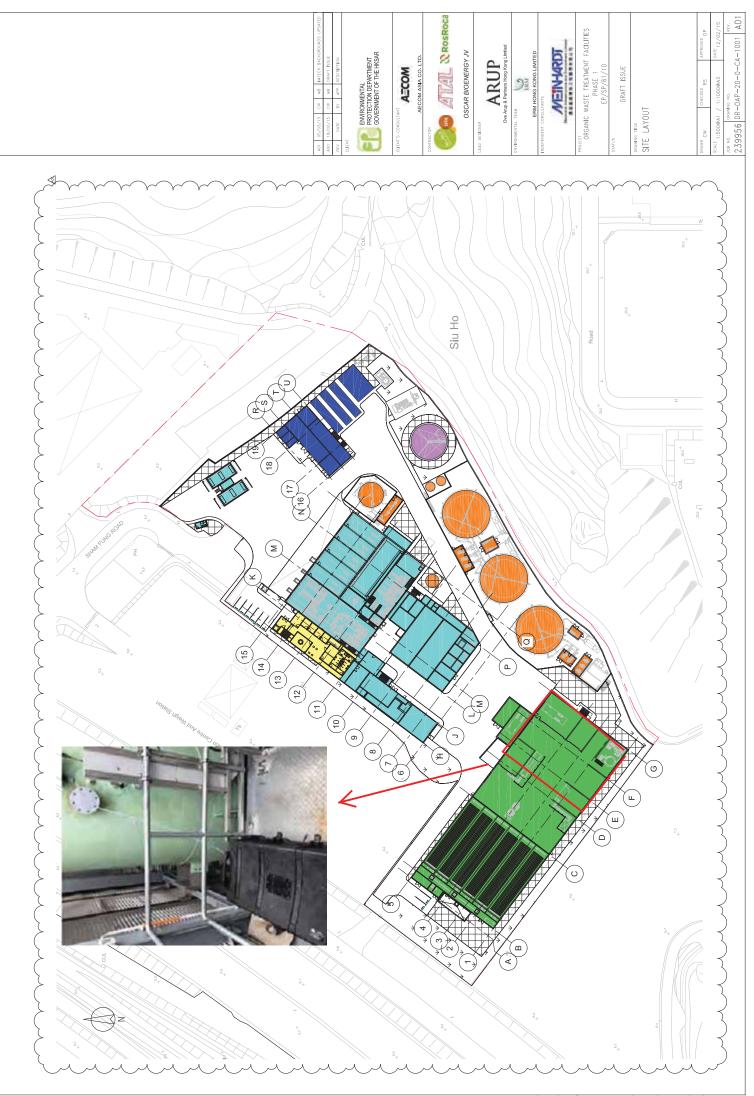
Date	31 August 2018		
Time	11:04-11:07 am		
Monitoring Location	Centralized Air Pollution Control (CAPC) Unit ((Detailed		
	location and photos shown on the marked drawing DR-OAP-		
	20-0-CA-1001 attached as Appendix A)		
Weather	Fine		
Parameter	Odour		
Exceedance Description	 On 31 August 2018, air samples were collected from the outlet of the Centralised Air Pollution Control (CAPC) unit by ALS for measurement of the Odour Intensity by olfactometry analysis at the laboratory. According to the EM&A Manual and EP requirements, it is considered an exceedance if the odour level is more than 220 OU/Nm3. the odour level of the odour samples collected from the CAPC unit have exceeded the odour limits stated in Table 2.2 of the EM&A Manual. (The detail sampling results are shown in Appendix B.) Odour emitting activities, including wastewater treatment plant and ammonia stripping plant (ASP) were operating on 31 August 2018. No organic waste were being processed the time the odour samples were being collected, due to pre-treatment line was stopped and only operated at mid night. The CAPC system was operating during the odour sampling. The contractor reported that the active carbon (AC) filter and the venturi scrubber in Building 2 were operating. The wet & chemical scrubbers were not operating at the time of the sampling as it is still under testing and commissioning. The exceedance could be due to saturation of the AC filter as an increase of VOCs concentration was observed.

Action Taken / Action to be	The contractor has replaced all AC filter media in the last week		
Taken	of September 2018. (Photograph record attached as Appendix C .)		
Remedial Works and	To avoid saturation of the filter media, it is recommended that		
Follow-up Actions	the contractor should test the medium regularly or indicator		
	medium should be used to provide an indication of the		
	condition of the media.

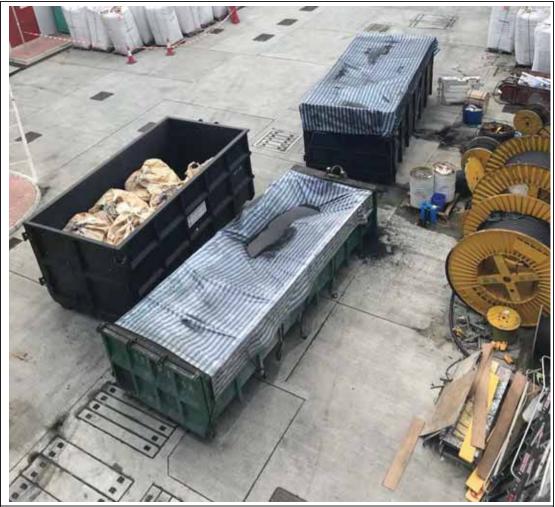
The Activate Carbon (ACs) were standby for replacement on site in mid-September 2018.

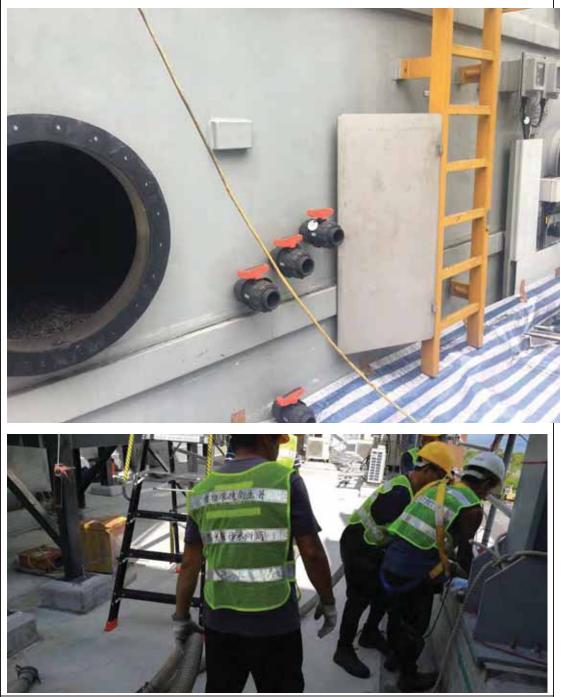
The ACs were being replaced by on site workers.

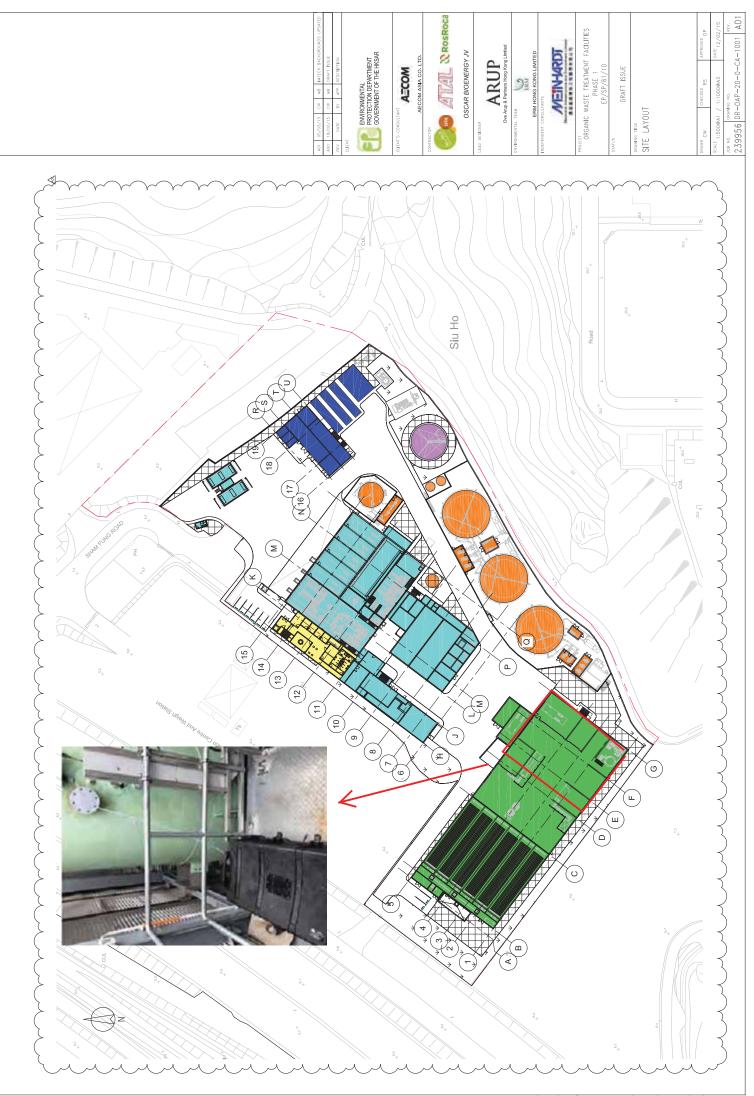
Date	5, 12, 19 and 26 October 2018; 1 and 5 November 2018		
Time	Sampling times were shown in Appendix D .		
Monitoring Location	Centralized Air Pollution Control (CAPC) Unit ((Detailed location and photos shown on the marked drawing DR- OAP-20-0-CA-1001 attached as Appendix C)		
Weather	Fine		
Parameter	Odour		
Exceedance Description	 On 5, 12, 19, 26 October 2018 and 1, 5 November 2018, air samples were collected from the outlet of the Centralised Air Pollution Control (CAPC) unit by ALS for measurement of the Odour Intensity by olfactometry analysis at the laboratory. According to the EM&A Manual and EP requirements, it is considered an exceedance if the odour level is more than 220 OU/Nm3. the odour level of the odour samples collected from the CAPC unit have exceeded the odour limits stated in Table 2.2 of the EM&A Manual. The detail sampling results are shown in Appendix D. The plant was operated normally. Odour emitting activities, including wastewater treatment plant, waste receiving pretreatment, AD process, sludge dewatering and composting were operating on those sampling days. The CAPC system was operating during the odour sampling. The plant received an average of 100 tonnes of SSOW daily in the reporting period. The contractor reported that CAPCS system was running with 1 of 2 line chemical scrubber, wet scrubber and venturi scrubber with activated carbon (AC) filter. Another 1 of 2 line chemical scrubber, wet scrubber and venturi scrubber were not operating at the time of the sampling as they are still under testing and commissioning. The exceedances could be due to saturation of the AC filter as an increase of VOCs concentration was observed.

Action Taken / Action to be Taken	The contractor has replaced all AC filter media in mid (15 th - 20 th) of November 2018 (Photograph record attached as Appendix E). The odour sampling collected on 23 November 2018 from CAPCs complied with EM&A Manual.		
Remedial Works and Follow-up Actions	To avoid saturation of the filter media, it is recommended that the contractor should test the medium regularly or indicator medium should be used to provide an indication of the condition of the media. ET will carry out follow-up audit regarding the progress next month.

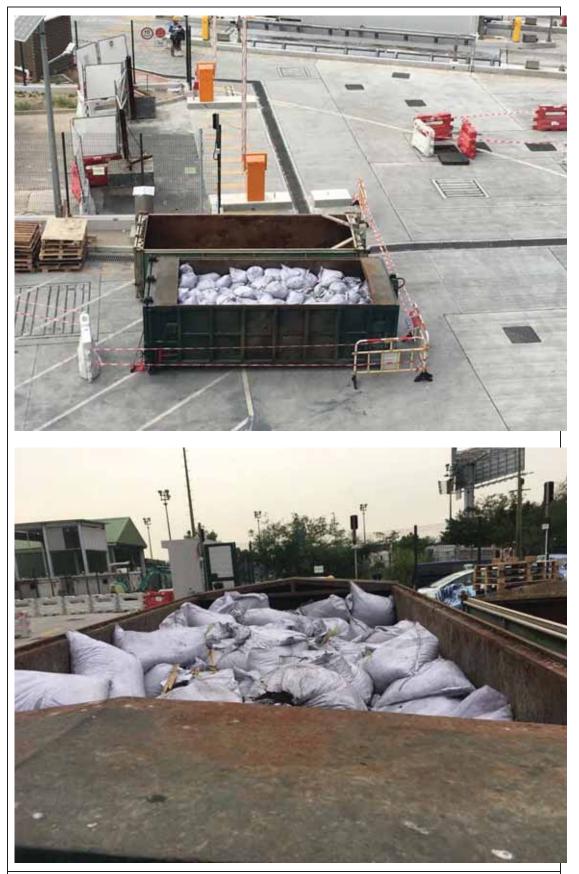
The activated carbons (ACs) were standby for replacement on site in mid-November 2018.

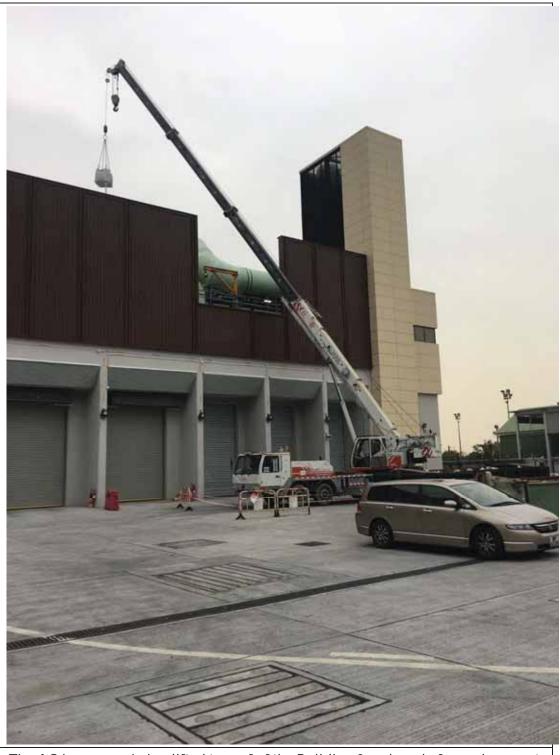
The AC bags were being lifted to roof of the Building 2 and ready for replacement.
