ANNEX F

INVESTIGATION REPORT

Investigation Report of Environmental Non-Compliance

EP/SP/61/10 – Organic Resources Recovery Centre Phase 1

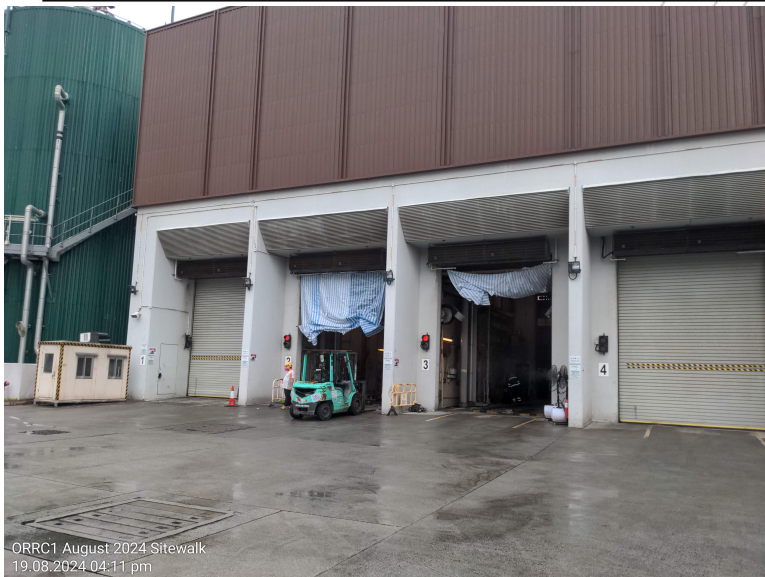
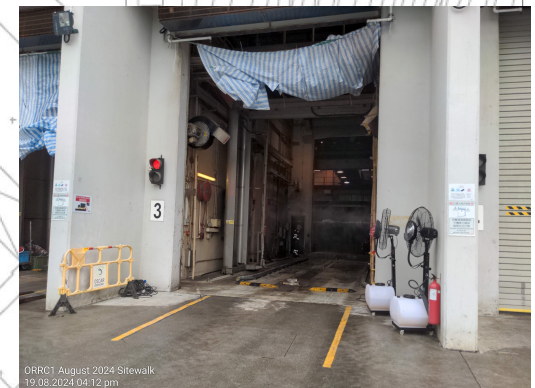
Date	19 August 2024
Time	4:10 pm
Location	Waste storage area of the main building (Detailed location and photo shown on the marked drawing Figure 3 – Site Layout attached as Appendix A)
Weather	Light rain
Non-Compliance #2	Waste storage area was suspected not operating under negative pressure as doors were broken
Relevant Requirement	EP Condition 4.2: <i>The main buildings (including waste reception and pre-treatment area, temporary storage area for shredded materials and dewatering process area, composting area and storage area) and wastewater treatment area, as shown in Figure 3, shall be operated under negative pressure to avoid escape of odour. Air in these areas shall pass through the centralized air pollution control unit for treatment before discharge.</i> General Conditions (epd.gov.hk)
Incident Description	During the August 2024 monthly site audit by the Monitoring Team (MT) and Independent Environmental Checker (IEC) together with the Contractor, both internal and external doors for keeping negative pressure of the waste storage area were found to be broken. The waste storage area was opened and suspected not operating under negative pressure. Odour was observed around the area.

Date	19 August 2024
Time	4:20 pm
Location	Temporary chemical storage area near eastern exterior wall of Main Building of the Site (Detailed location and photo shown on the marked drawing Figure 3 - Site Layout attached as Appendix A)
Weather	Light rain
Non-Compliance #1	Suspected Chemical Spillage
Relevant Requirements	<p>Chemicals and Chemical Wastes Handling & Storage (EM&A Manual July 2019 – Revision F: Appendix A – Implementation Schedule of Mitigation Measures, EM&A Log Ref 5.22-5.25 (pg. 22-25), attached as Appendix B).</p> <p>In particular, Section 5.22 (i) First bullet: <i>“chemicals and chemical wastes should only be stored in suitable containers in purpose-built area.”</i></p> <p>Fifth bullet: <i>“Storage containers should be checked at regular intervals for their structural integrity and to ensure that the caps or fill points are tightly closed.”</i></p>
Incident Description	During the August 2024 monthly site audit by the Monitoring Team (MT) and Independent Environmental Checker (IEC) together with the Contractor, orange/ brown-coloured stains were observed on the ground and exterior wall of the Main Building. Various chemicals (i.e. FeCl ₃ and H ₂ SO ₄) in containers were observed. Some containments were found overflow to surroundings.
