Investigation Report

OSCAR Bioenergy Joint Venture
EP/SP/61/10 – Organic Resources Recovery Centre Phase 1

Investigation Report of Intermediate Digestate Tank Leakage

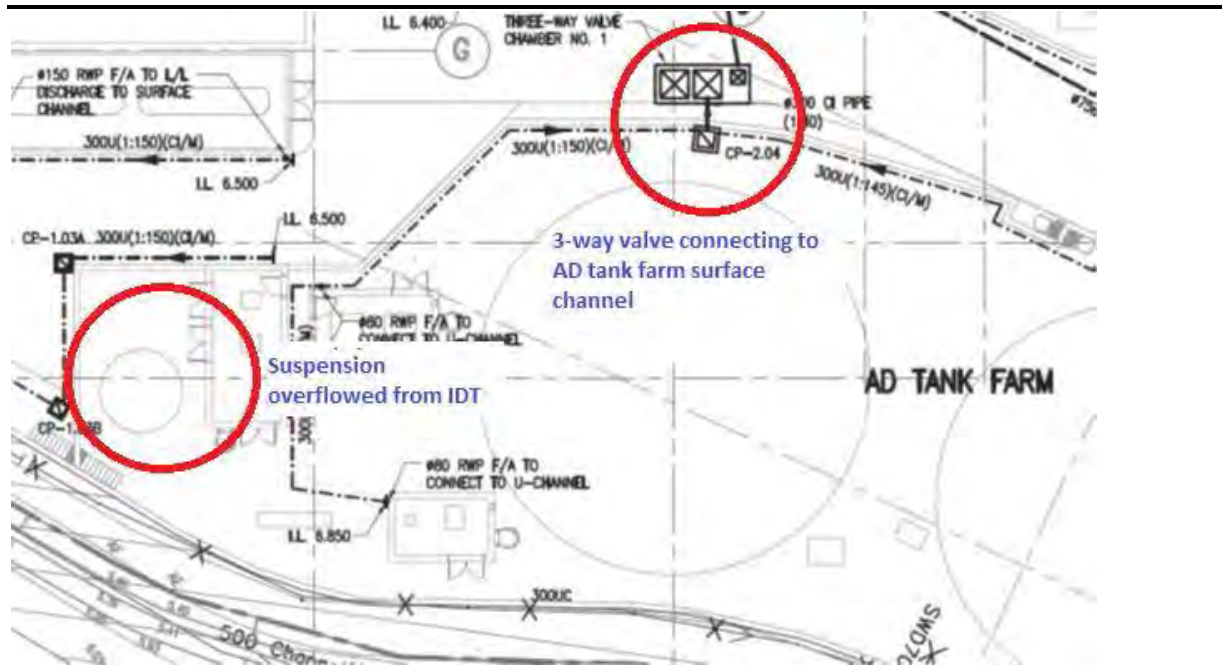
Figure.6 Location map of the incident

On 28 December 2019 morning at around 10:00 am, some black water was found discharging slowly to the nullah from the storm water discharge outlet. Investigation was carried out immediately and found that suspension was passing from the 3-way gate valve near AD3.

7. The 3-way valve was closed at the time of the outbreak. Unfortunately the 3-way valve was not able to tight seal and some of the suspension passed through the valve and leaked to the nullah slowly.

1. To check and fully close the 3-way gate valve to prevent possible leakage to nullah.
2. To carry out dye test to check the 3-way valve is fully closed.
3. To keep close monitoring the IDT level for each process (centrifuge and flushing).
4. To carry out programme enhancement to avoid injection of flushing water to IDT that may due to any interruption of programme sequence/logic.
