Investigation Report

Investigation Report of CEMS Exceedances

OSCAR Bioenergy Joint Venture
EP/SP/61/10 – Organic Resources Recovery Centre Phase 1

Investigation Report of Intermediate Digestate Tank Leakage

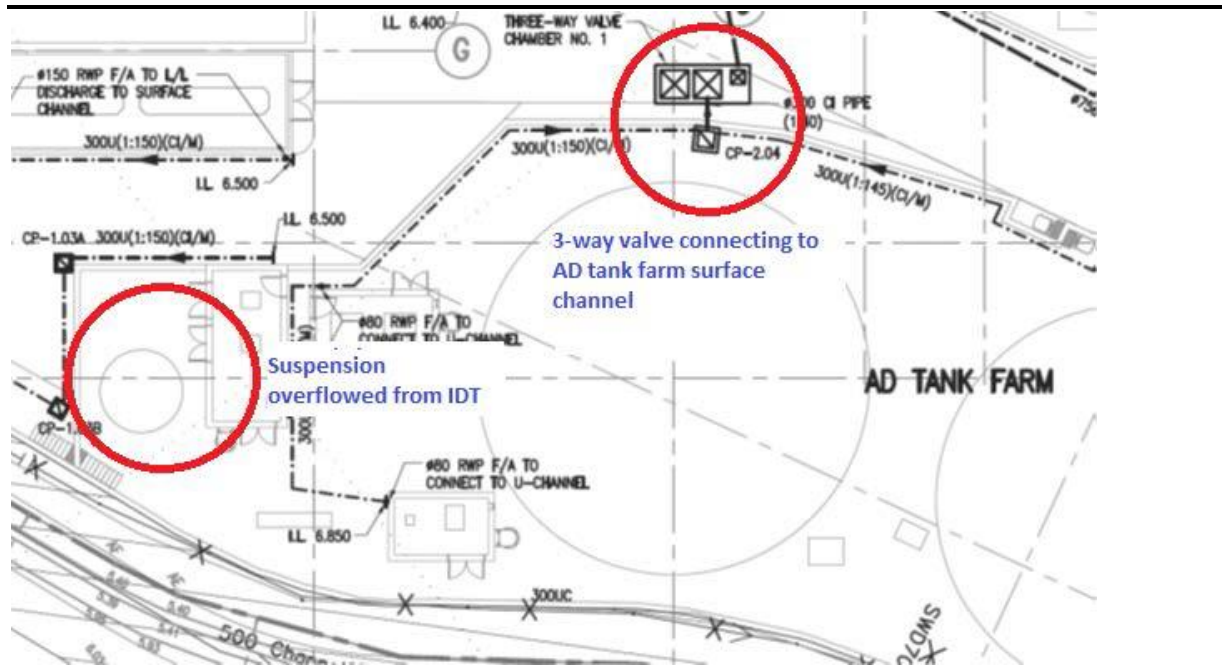
Figure.4 Location map of the incident

On 5/11/2019 morning at around 7:50am, black water was found discharging to the nullah from the storm water discharge channel. The team immediate carried out investigation to identify if there had any leakage from the plant. It was found that suspension was overflowed from the overflow tank of IDT to the surface channel inside AD tanks farm. Operation Team immediate contacted the Central Control Room to stop all feedings to the IDT. The suspension was stopped overflowed from the IDT overflow tank immediately.

1. After the dewatering process, the team started flushing the system. However, the team did not aware that process water was injecting to the IDT.
2. Process water will stop injecting to IDT by a default period. However, the process water injection was not stopped. *(To be further investigated by system programmer)*
3. The team did not aware the IDT tank was reaching high level and overflowed to the overflow tank
4. Process water with residual suspension overflowed from IDT to the overflow tank.
5. Process water with residual suspension overflowed to the surface channel at AD tank farm and discharged to the nullah.
6. The 3-way valve (*Figure 4*) is believed opened 1-2 months ago because of a heavy rainstorm. The 3-way valve however did not close after the heavy rainstorm.

1. Stopped all the feedings to the IDT
2. Arranged to clean up the suspension leaked to the nullah by a vacuum tanker truck
3. Arranged to clean up the suspension at the surface channel near the IDT

1. To close the 3-way gate valve to prevent possible leakage to nullah (Figure 5)
2. To keep close monitoring the IDT level for each flushing process (duty suspensor will monitor each flushing process every time with the assistant of CCTV)
3. To increase the routine patrol frequency by one time per shift to 2 times per shift
4. To further investigate by system programmer to check if there have any programming bugs
