Investigation Report

OSCAR Bioenergy Joint Venture
EP/SP/61/10 – Organic Resources Recovery Centre Phase 1

Investigation Report of Intermediate Digestate Tank Leakage

Extract of the Incident Notification Form on Suspension Overflow at IDT Prepared by the Contractor

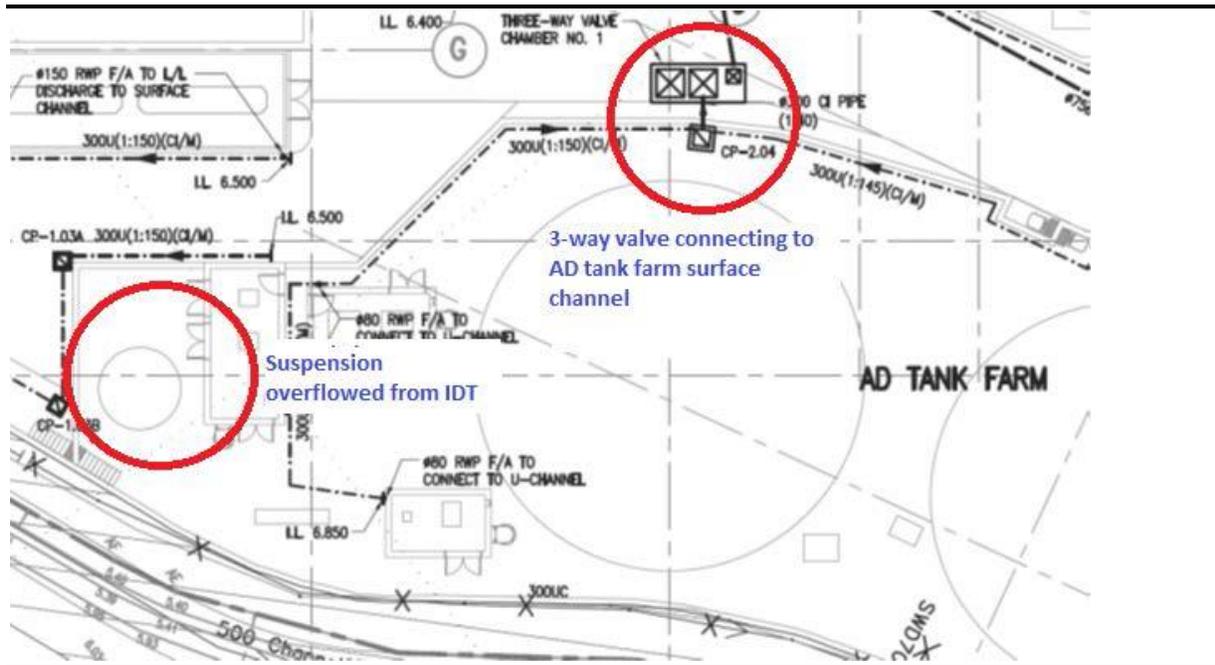
Figure.6 Location map of the incident

On 28 December 2019 morning at around 10:00 am, some black water was found discharging slowly to the nullah from the storm water discharge outlet. Investigation was carried out immediately and found that suspension was passing from the 3-way gate valve near AD3.

There was an incident happened in the early morning (around 08:30am). Suspension was overflowed from the IDT to the surface channel inside AD tanks farm (Figure 1). OSCAR was carrying out cleaning work inside the tank farm. OSCAR had checked the discharge outlet at around 9:30 and did not find any leakage at that moment. OSCAR also kept monitor the outlet by using CCTV. The 3-way gate valve was believed fully closed and the team did not aware suspension would pass through the 3-way gate valve.

7. The 3-way valve was closed at the time of the outbreak. Unfortunately the 3-way valve was not able to tight seal and some of the suspension passed through the valve and leaked to the nullah slowly.

1. Put sandbags at the discharge outlet to stop the leakage.
2. Arranged to clean up the suspension leaked to the nullah by a vacuum tanker truck.
3. Arranged to clean up the suspension at the surface channel near the IDT and inside AD tank farm.
4. Trouble shoot the centrifuge flushing control logic.

1. To check and fully close the 3-way gate valve to prevent possible leakage to nullah.
2. To carry out dye test to check the 3-way valve is fully closed.
3. To keep close monitoring the IDT level for each process (centrifuge and flushing).
4. To carry out programme enhancement to avoid injection of flushing water to IDT that may due to any interruption of programme sequence/logic.
