Annex K

Investigation Report –
Odour Sampling
Exceedances

OSCAR Bioenergy Joint Venture
EP/SP/61/10 – Organic Resources Recovery Centre Phase 1

Investigation Report of Treated Effluent Leakage

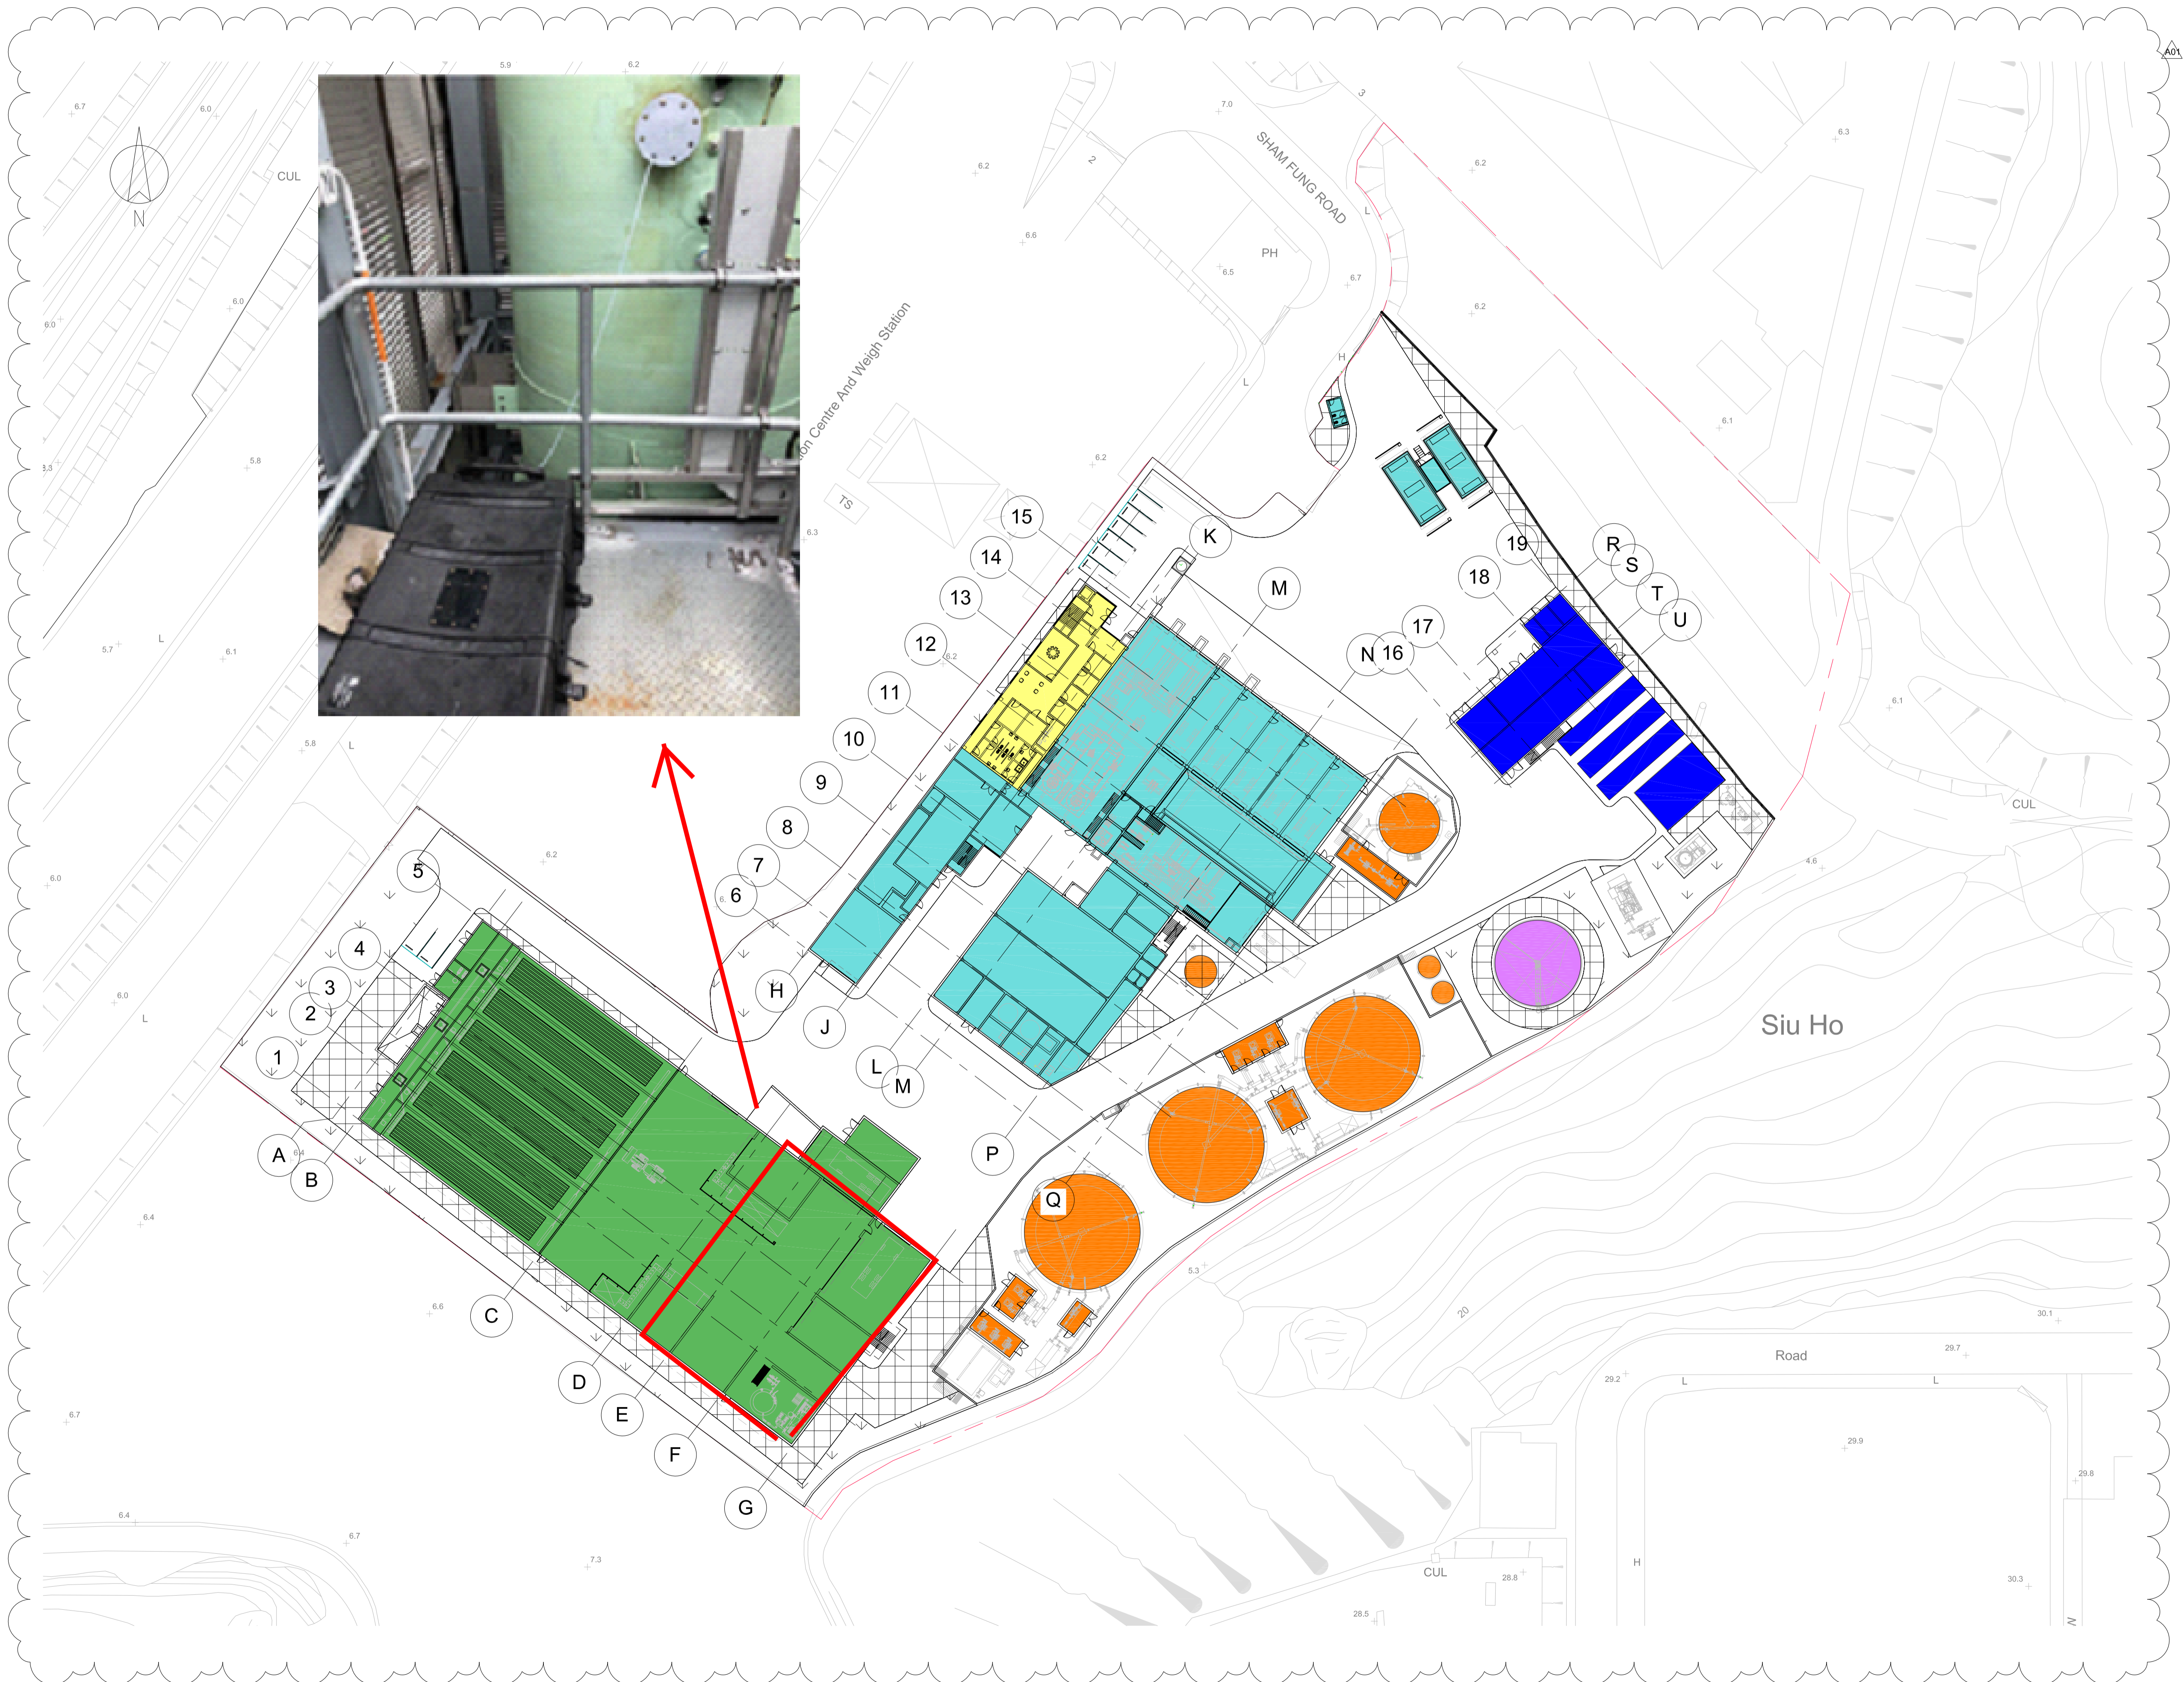
Date	10, 11, 19 and 27 December 2018; 16 January 2019
Time	Sampling times were shown in Appendix B .
Monitoring Location	Centralized Air Pollution Control System (CAPCS) ((Detailed location and photos shown on the marked drawing DR-OAP-20-0-CA-1001 attached as Appendix A)
Weather	Fine
Parameter	Odour
Exceedance Description	<ol style="list-style-type: none"> 1. On 10, 11, 19 and 27 December 2018 and 16 and 29 January 2019, air samples were collected from the outlet of the CAPCS by ALS for measurement of the odour concentration (in term of Odour Unit (OU) by olfactometry analysis at the laboratory. The EM&A Manual, has set an odour limit of 220 OU/Nm³ for the CAPCS stack. The odour concentrations of the odour samples collected from the CAPCS on 10, 11, 19 and 27 December 2018; 16 January 2019 have exceeded the odour limits. The odour analysis results are shown in Appendix B. 2. According to the Contractor, the plant was operated normally. Odour emitting activities, including waste reception and pretreatment process, AD process, wastewater treatment plant, sludge dewatering and composting process were operating on the sampling days. The CAPCS was operating during the odour sampling periods. 3. The plant received an average of 100 tonnes of SSOW daily in the reporting period. 4. The Contractor reported that the chemical dosing system of the CAPCS have some problems resulting in a high concentration of odorous gases H₂S and NH₃ in the exhaust air, which led to exceedances of the odour limit. In addition, the Contractor reported that the prepared of the chemical dosing system took longer than anticipated resulting in a prolonged exceedances recorded during December 2018.

Action Taken / Action to be Taken	Once it was identified that there was a problem with the chemical dosing system, the Contractor added the chemical to the system manually to minimise the exceedances. The Contractor has also contacted the supplier of the chemical dosing system to carry out repairing work so that the system can function properly.
Remedial Works and Follow-up Actions	The Contractor is recommended to closely monitor the operation of the chemical dosing system to avoid the reoccurrence of similar problem. The system is fixed and the odour concentration of the air sample taken on 29 January 2019 showed compliance with the odour limit.
